AHU Condition Report

20 Bank Street

Reference: Q1734/2107

Air Handling Unit - Condition Report

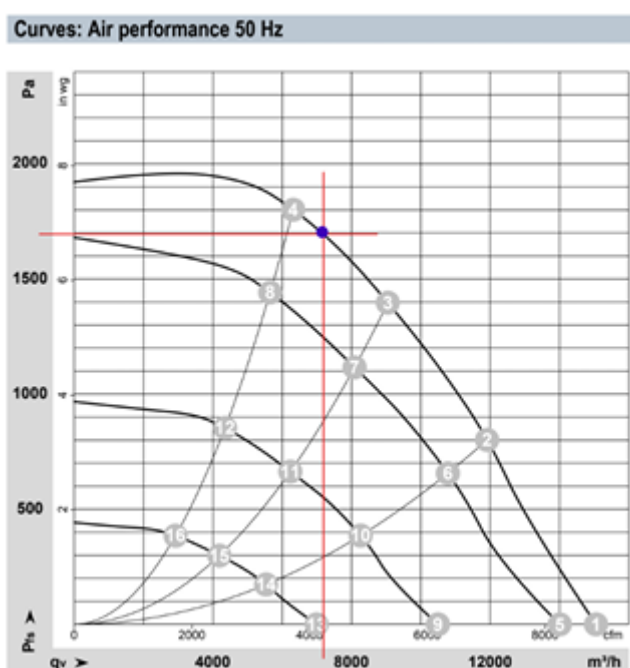
From the information provided it would seem that the EC fan upgrade involved the installation of 21 x K3G450-PB24-01, after reviewing the below fan curve and assuming a required duty of 2m³/s (7200m³/h) @ 1989Pa per fan it is questionable that original duty can be achieved even with the fan operating at full speed.

The maximum achievable static pressure at 2m³/s will be circa 1700Pa. Any additional system pressure will result in a loss of volume as the duty point travels left along the full speed curve.

It is important to ascertain the actual system conditions (determination of the system line) in conjunction with a definitive statement as to the required air volume before any consideration relating to additional energy saving potential can be made.

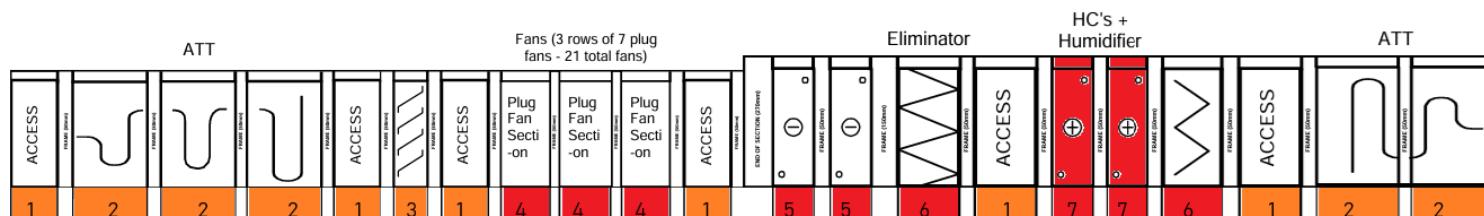
Office Primary Air Handling Unit – South & North

(AHU/R-01 & AHU/R-02) colour coded section by section
