AHU Condition Report

EastWest, Nottingham

Reference: Q1647/24.07.2024

Air Handling Unit - Condition Report

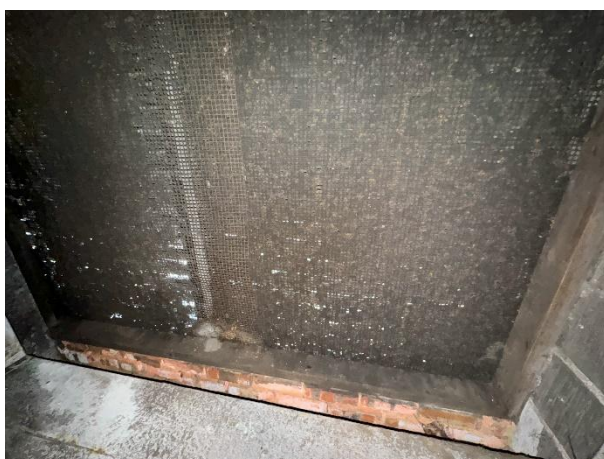
The fresh air inlet for the AHU is facilitated through an external weather louvre with insect mesh affixed to the rear. The insect mesh is almost completely clogged with dirt and debris. Immediately after the fresh air intake is an inlet damper which has been damaged with almost half of the damper blades missing from the damper itself. The damper is controlled by one actuator with an interconnecting linkage connecting the top damper to the bottom damper to operate as one. Currently, the top half of the damper can open and close if the actuator is operational, however the bottom half of the damper will remain open due to the missing blades.

Insect mesh behind louvres

- Remove the insect mesh on the intake louvres.
- Remove the fresh air inlet damper.
- Supply and install new G4 panel filter to the air on side of the frost coil.

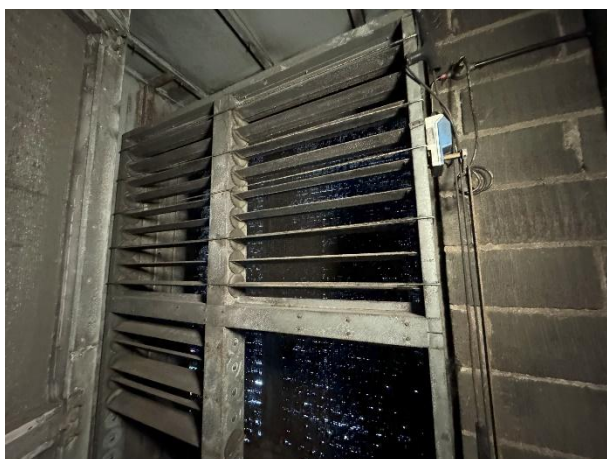
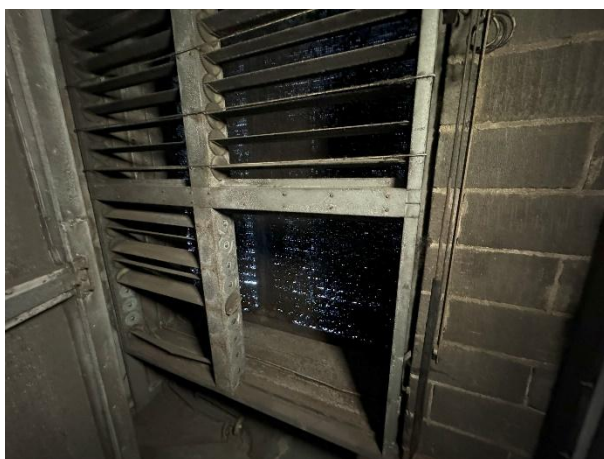
Fresh air inlet damper

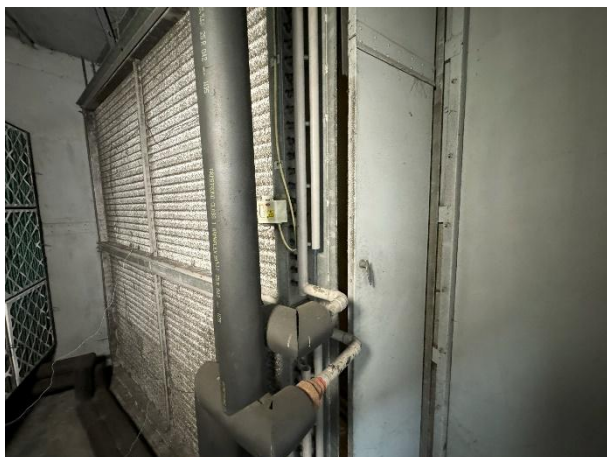
The frost coil is the next component within the AHU and is in poor condition with the fins deteriorating. The panel and bag filters seem to be in reasonable condition and should continue to be monitored and replaced regularly in line with ongoing maintenance requirements. An attenuator is installed after the bag filters which seems to have been installed in September 2008 and is in reasonable condition with some minor signs of corrosion.

Frost coil

- Replace the existing frost coil.
- The new frost coil should be connected to a new air source heat pump.
- Replace the panel and bag filters.
- Remove the main heating coil from the system.

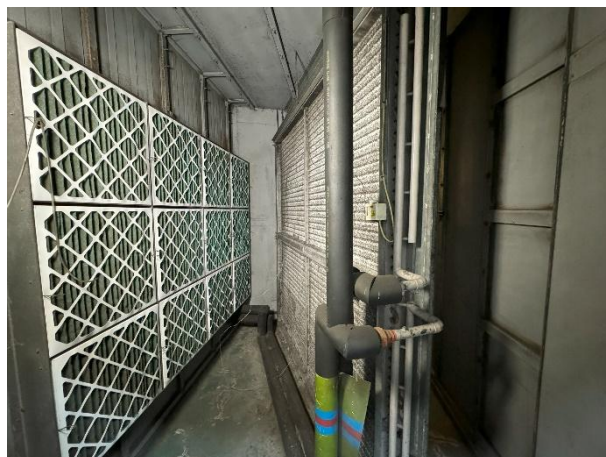
Panel filters

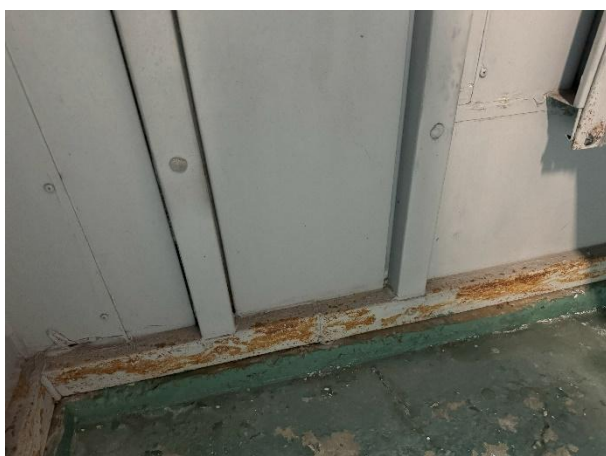
Corrosion

- Clean and lubricate the manual VCDs.
- Clean and treat the internal corrosion throughout the AHU.

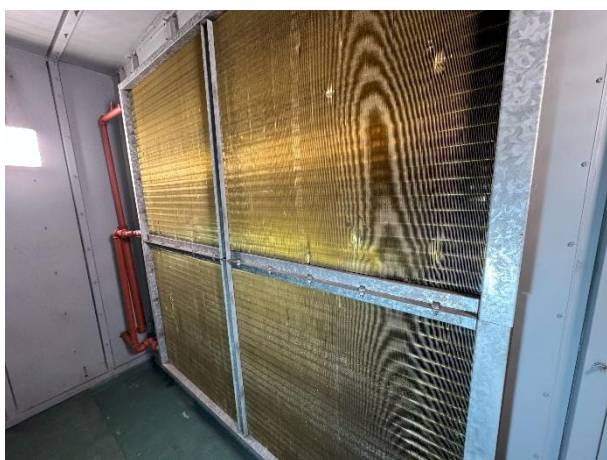
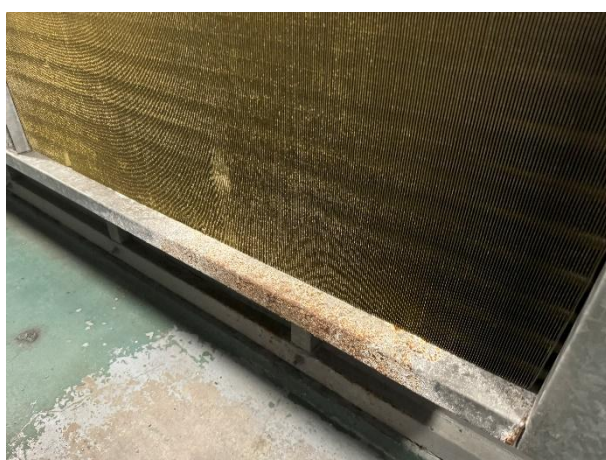
The main heating coil, like the attenuator, seems to be a replacement. Although the installation date is unclear, the coil is in reasonable condition with minor fin damage and some corrosion on the frame. The CHW cooling coil also appears to be in reasonable condition at first glance; however, thorough inspection revealed excessive corrosion around the coil headers. The associated moisture eliminators are in reasonable condition. A condensate pump is installed within the floor of the fan section, connected to the cooling coil's drain tray.

Main heating coil

Corrosion on main heating coil

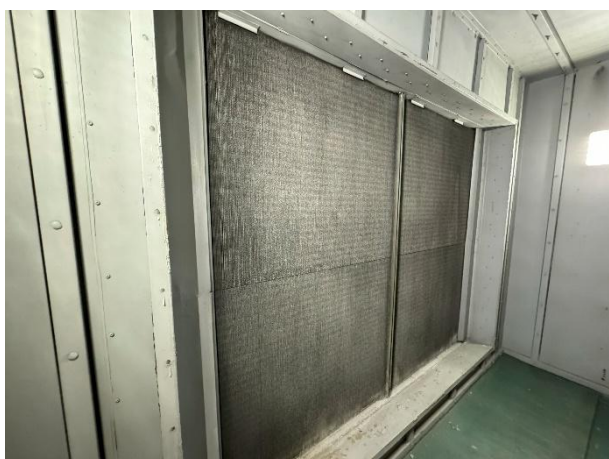
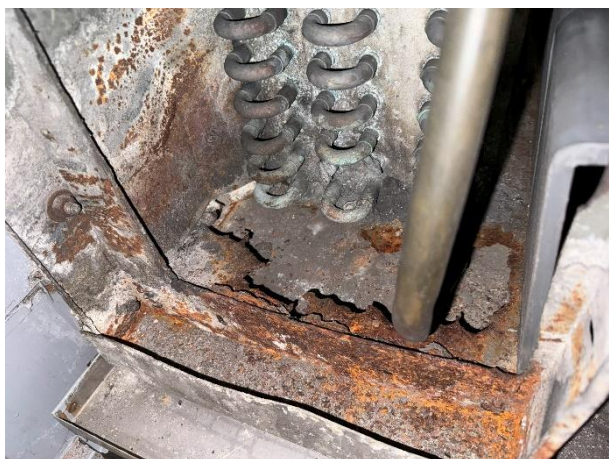
CHW cooling coil

Corrosion on CHW coil headers

- Replace the existing CHW cooling coil with a new DX heat pump coil that provides cooling and heating.
- The new DX heat pump coil should be connected to a heat pump condensing unit.

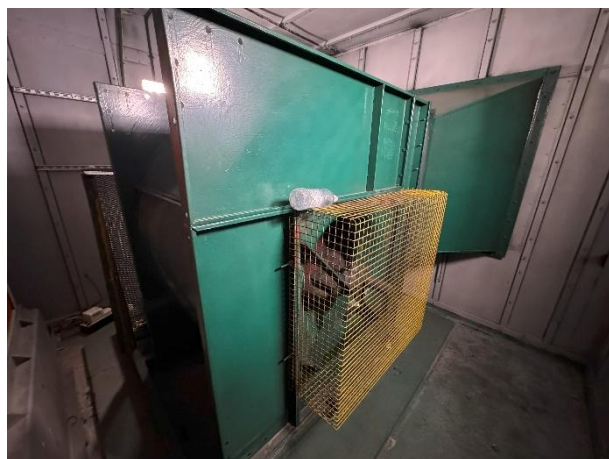
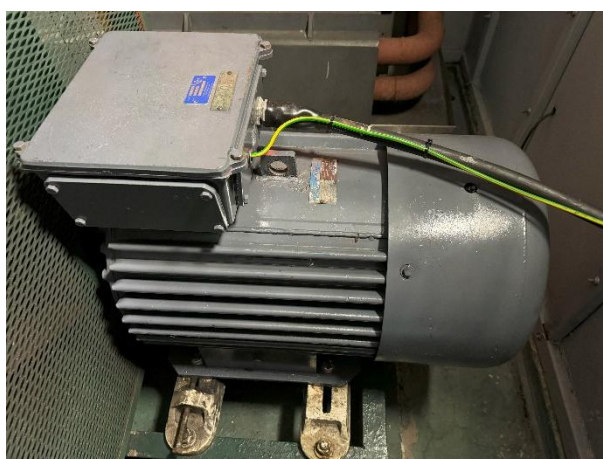
The existing belt driven fan and motor is the original from date of installation. This has surpassed its recommended CIBSE guide M life cycle by several years. We therefore recommend this is upgraded to new energy efficient direct drive EC plug fans.

Belt driven fan

Motor

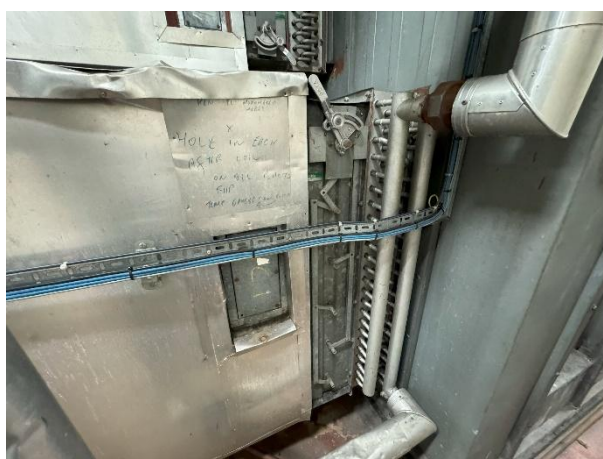
The AHU branches into 3 main ducts each with their own duct mounted heating coils to provide zonal temperature control to the areas served. Immediately after the coils is a manual Volume Control Damper (VCD) to balance airflow. The coils were in poor condition and have exceeded their recommended life expectancy according to CIBSE guide M. There are small access hatches installed after the VCDs in the ductwork to facilitate cleaning the dampers and air off side of the coils. There is cabling obstructing the removal of one of the coils.

Duct mounted coil, VCD, and obstructing cabling

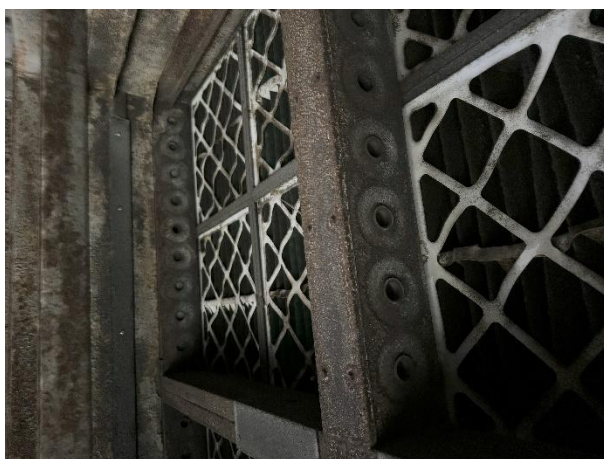
The fresh air inlet for the AHU is facilitated through an external weather louvre which has had the insect mesh removed. The inlet damper has also been removed from the AHU with a new panel filter frame installed housing 98mm deep G4 panel filters. We believe this was retrofitted to combat the issues we found when surveying AC1. There is a large amount of corrosion within this section of the AHU that should be cleaned and treated. The panel filters were dirty and should be replaced.

Old damper casing

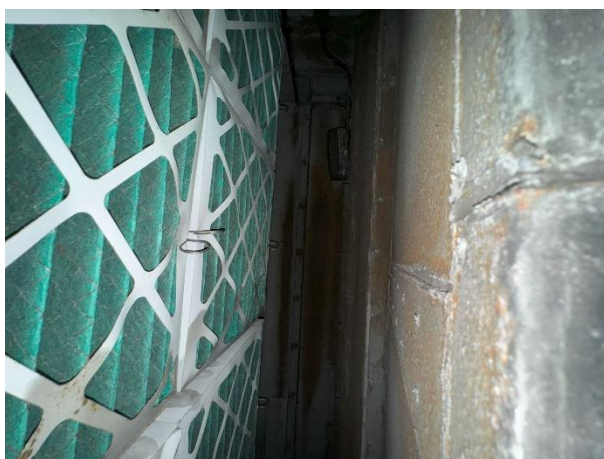
Corrosion

- Clean and lubricate the manual VCDs.
- Clean and treat the internal corrosion throughout the AHU.

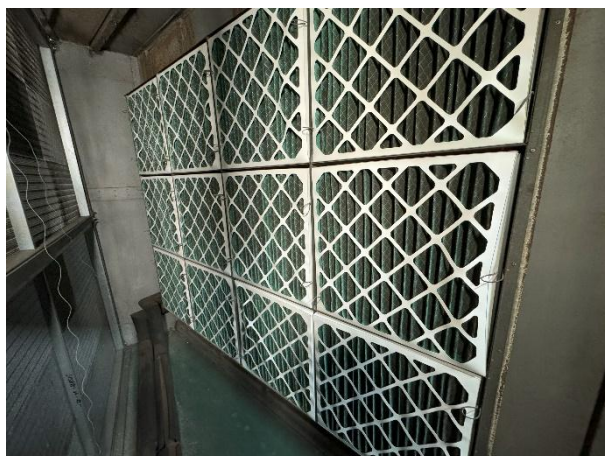
There is not a requirement to keep two banks of the same grade of panel filters as this is adding unnecessary pressure drop to the AHU and higher maintenance costs. An attenuator is installed after the bag filters which is in reasonable condition.

Panel filters

- Replace the existing frost coil.
- The new frost coil should be connected to a new air source heat pump.
- Replace the panel and bag filters.
- Remove the second bank of panel filters from the AHU.

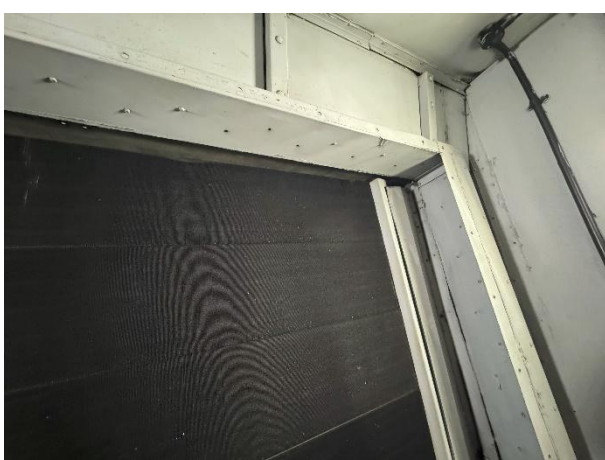
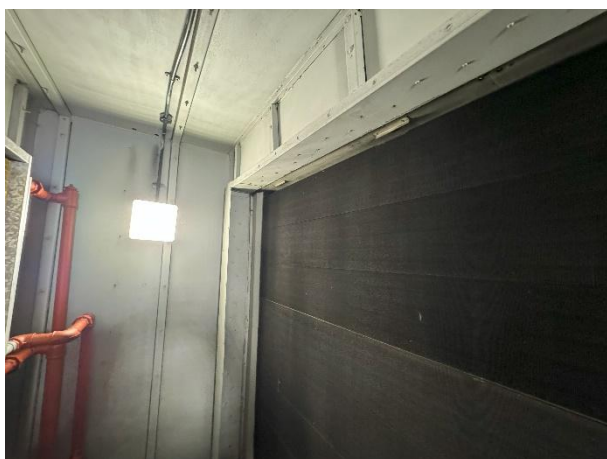
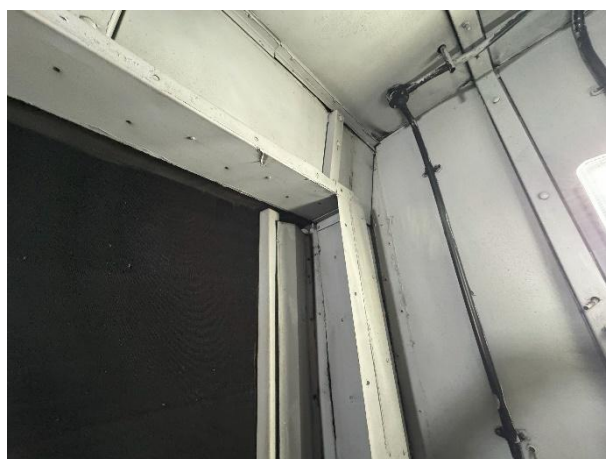
The main heating coil is in reasonable condition with minor fin damage. The CHW cooling coil also appears to be in reasonable condition. There are no associated moisture eliminators for this coil. Upon closer inspection, the casework has buckled around the perimeter of the cooling coil with various popped rivets which is affecting the structural integrity of the AHU.

This urgently needs attention as if left has the potential to cause catastrophic failure and irreparable damage to the AHU. The drain tray of the cooling coil is in poor condition and seems to partially supported by parts of wood.

CHW cooling coil buckled casework

- Remove the main heating coil from the system.
- Replace the existing CHW cooling coil with a new DX heat pump coil that provides cooling and heating.
- Repair the casework around the perimeter of the new DX heat pump coil.

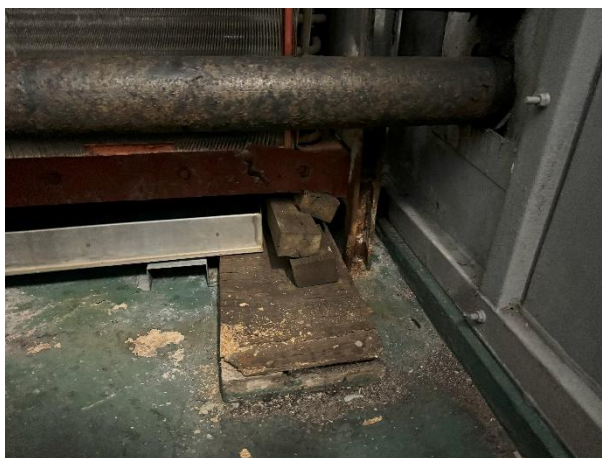
Wooden supports

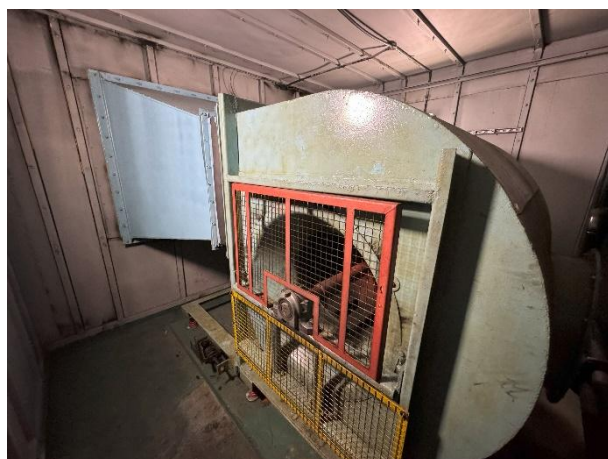
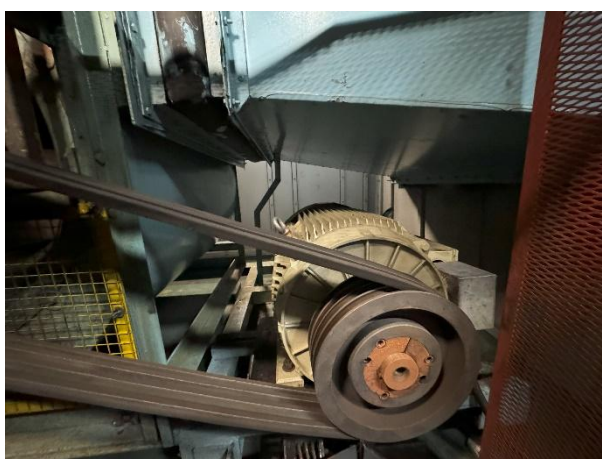
The existing belt driven fan and motor is the original from date of installation. This has surpassed its recommended CIBSE guide M life cycle by several years. We therefore recommend this is upgraded to new energy efficient direct drive EC plug fans.

Belt driven fan

Motor

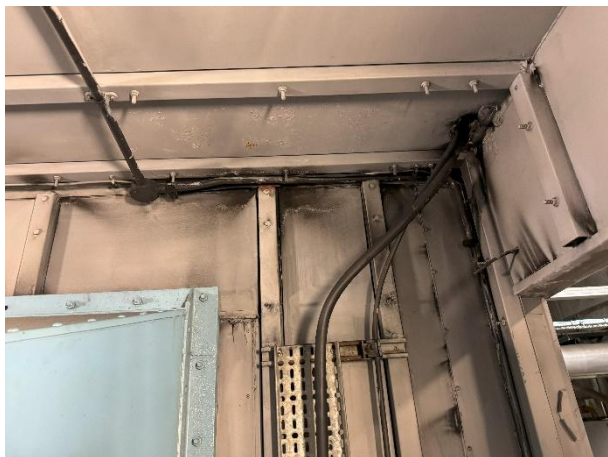
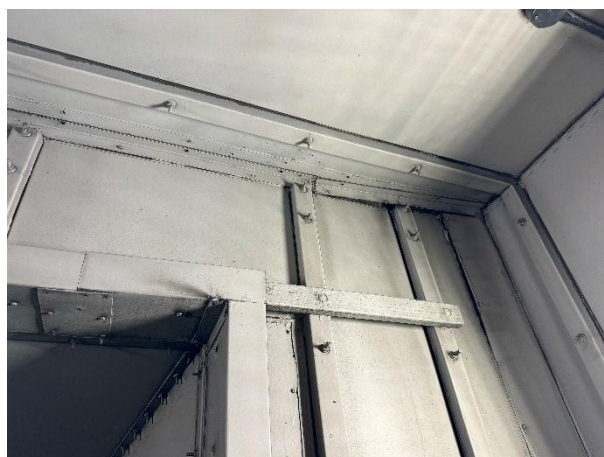
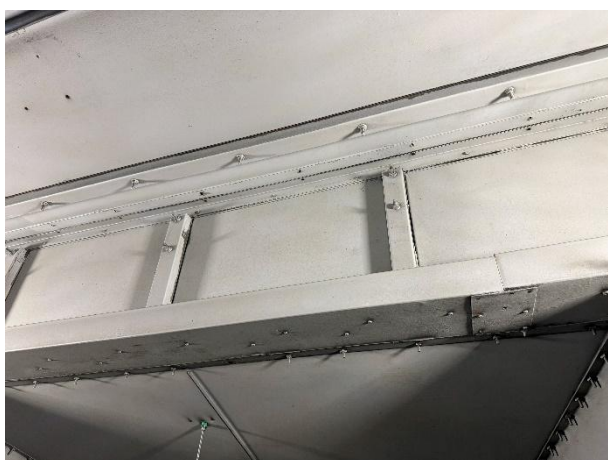
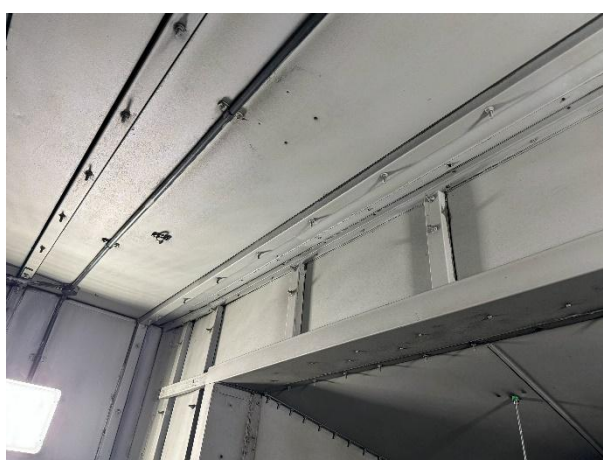
Buckling casework

Popped rivets

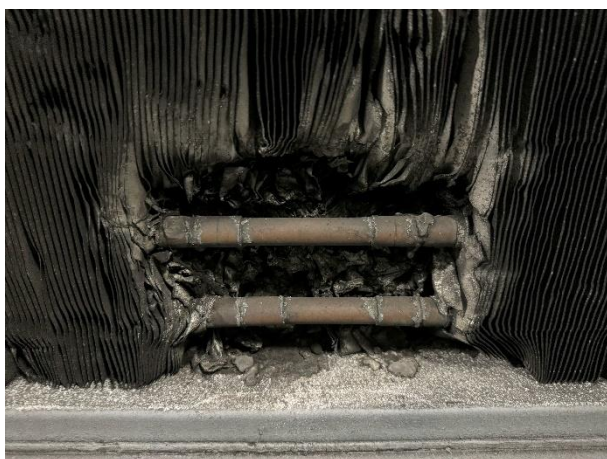
We also surveyed AC3 whilst on site and found the unit to be identical in terms of design, component layout, and condition with the inverter running at 40Hz. One of the duct mounted coils for AC3 has had some repairs to the tube of the coil.

AC3 Coil repair

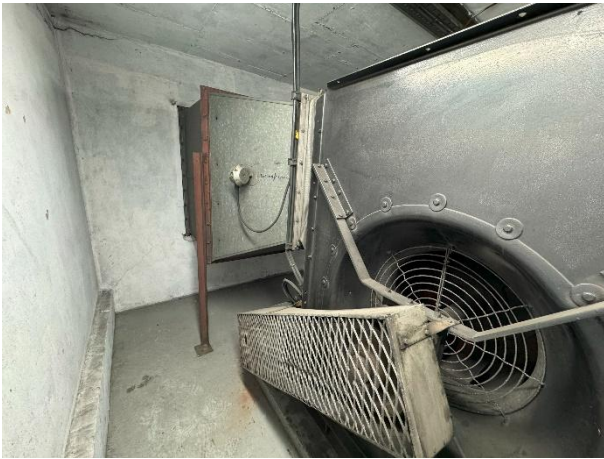
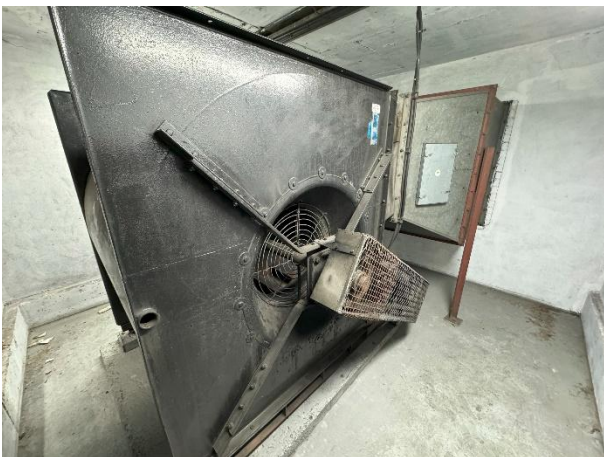
The existing belt driven fan is the original from date of installation, this has surpassed its recommended CIBSE guide M life cycle by several years. We therefore recommend this is upgraded to new energy efficient direct drive EC plug fans. The fan is connected to run and standby motors which appear to have been replaced in 2007.

Belt driven fan and attenuator

- Upgrade the existing belt driven fan and motor to new energy efficient direct drive IE6 EC plug fans to improve system reliability and energy efficiency.
- Due to the construction of the room that houses the fan, we recommend the new EC plug fans are installed in their own dedicated casework as the change from negative to positive pressure within the fan chamber could cause damage to the building fabric and significant air leakage.

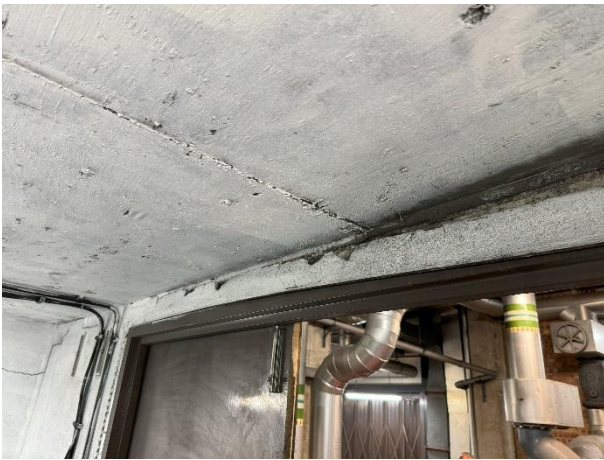
There is an attenuator installed directly after the fan outlet with no access to inspect the condition. The brickwork is exposed around the perimeter of the double doors leading to the fan, we would recommend this is repointed as we expect the excessive negative pressure build up within the room could eventually cause large fragments of brick to break away and cause damage to the mechanical components.

Damage to building fabric

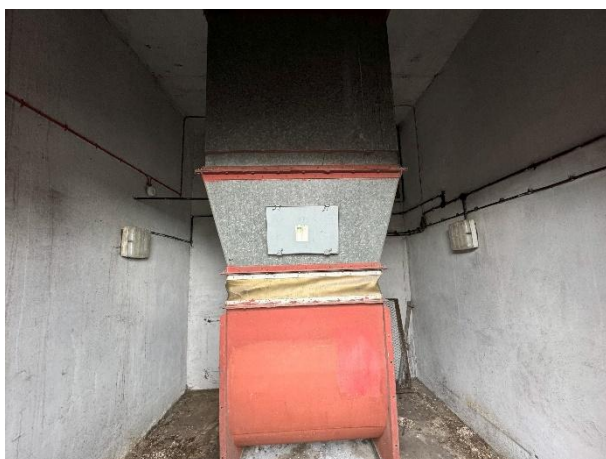
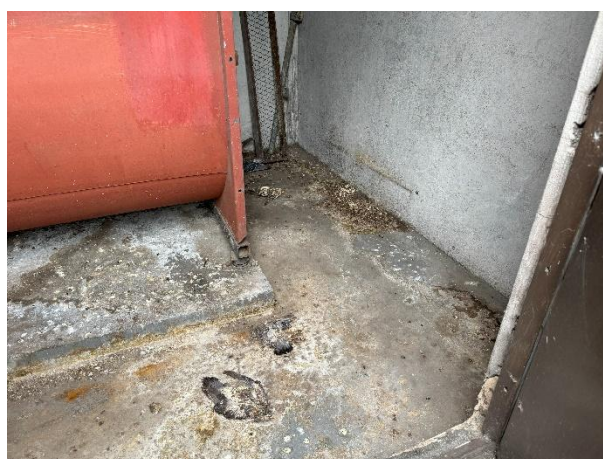
Before any works are conducted in this plantroom, there is a requirement for a deep clean by a specialist contractor.

Belt Driven Fan

- Deep clean the plantroom prior to any works.
- Upgrade the existing belt driven fan and motor to new energy efficient direct drive IE6 EC plug fans to improve system reliability and energy efficiency.
- Due to the construction of the room that houses the fan, we recommend the new EC plug fans are installed in their own dedicated casework as the change from negative to positive pressure within the fan chamber could cause damage to the building fabric.

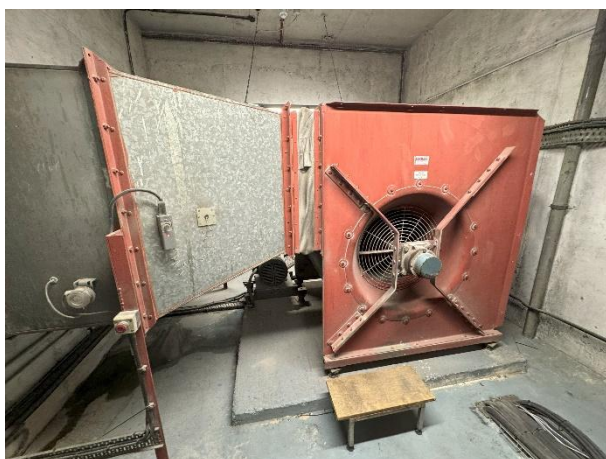
The existing belt driven fan is the original from date of installation, this has surpassed its recommended CIBSE guide M life cycle by several years. We therefore recommend this is upgraded to new energy efficient direct drive EC plug fans.

Belt Driven Fan

- Upgrade the existing belt driven fan and motor to new energy efficient direct drive IE6 EC plug fans to improve system reliability and energy efficiency.
- Due to the construction of the room that houses the fan, we recommend the new EC plug fans are installed in their own dedicated casework as the change from negative to positive pressure within the fan chamber could cause damage to the building fabric.

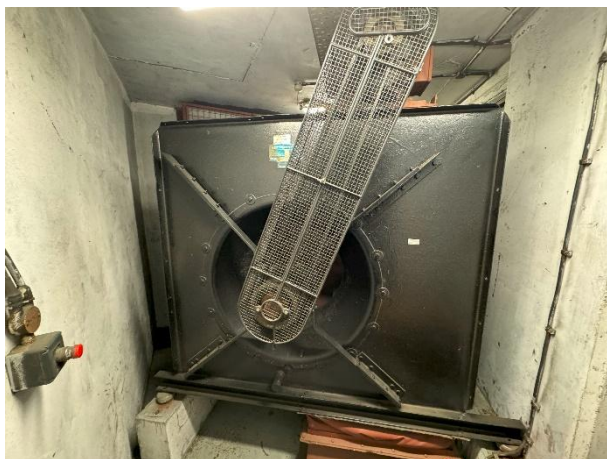
The existing belt driven fan is the original from date of installation, this has surpassed its recommended CIBSE guide M life cycle by several years. We therefore recommend this is upgraded to new energy efficient direct drive EC plug fans.

Belt Driven Fan

- Upgrade the existing belt driven fan and motor to new energy efficient direct drive IE6 EC plug fans to improve system reliability and energy efficiency.
- Due to the construction of the room that houses the fan, we recommend the new EC plug fans are installed in their own dedicated casework as the change from negative to positive pressure within the fan chamber could cause damage to the building fabric.

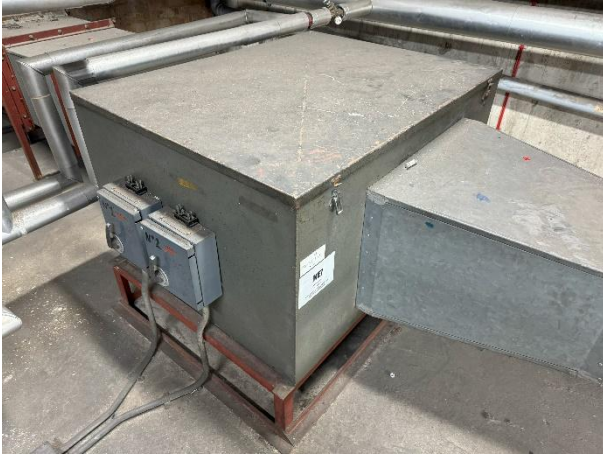
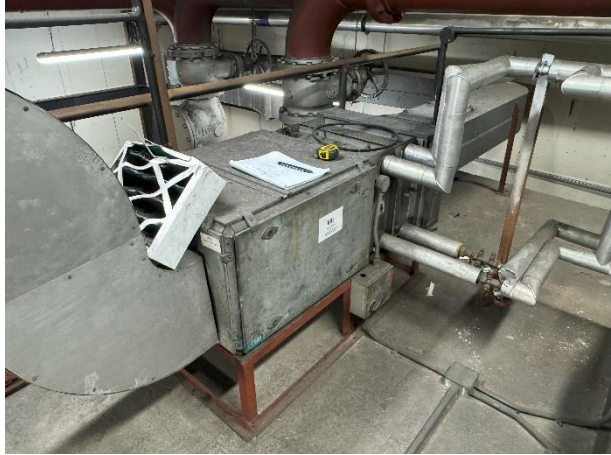
ME7

Due to the size of the unit, it is not economical to refurbish therefore we would recommend replacing the unit in its entirety with a new twin extract unit containing energy efficient direct drive EC plug fans.

Due to the size of the unit, it is not economical to refurbish therefore we would recommend replacing the unit in its entirety with a new supply unit containing energy efficient direct drive EC plug fans.

- Replace both the AHUs with new energy efficient versions c/w standalone controls.
- The new supply unit to contain an electric heater battery to negate the heating requirement from the boilers.

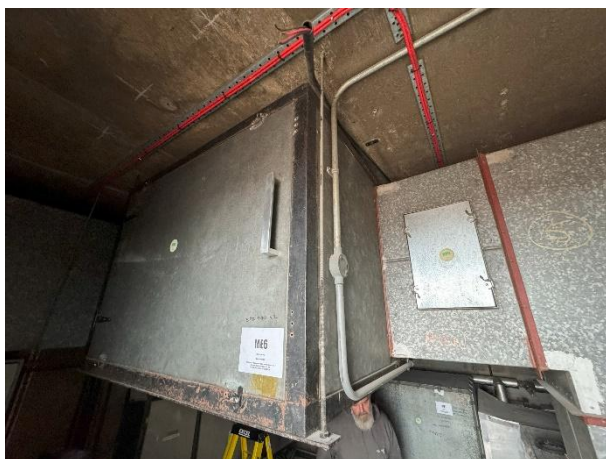
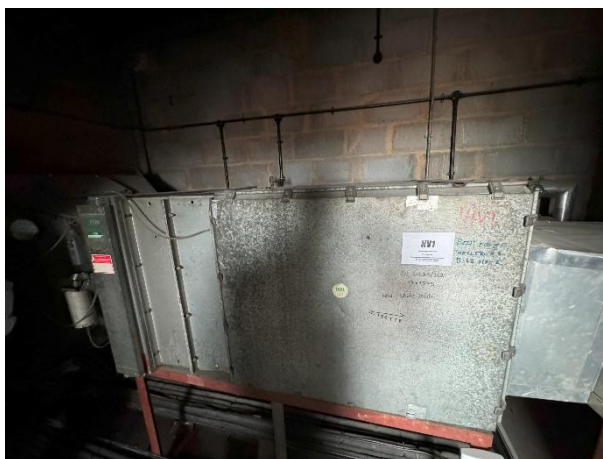
ME6

Due to the size of the unit, it is not economical to refurbish therefore we would recommend replacing the unit in its entirety with a new twin extract unit containing energy efficient direct drive EC plug fans.

Due to the size of the unit, it is not economical to refurbish therefore we would recommend replacing the unit in its entirety with a new supply unit containing energy efficient direct drive EC plug fans.

- Replace both the AHUs with new energy efficient versions c/w standalone controls.
- The new supply unit to contain an electric heater battery to negate the heating requirement from the boilers.

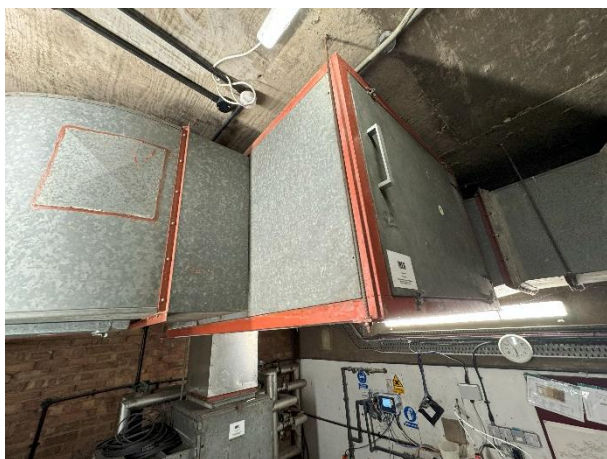
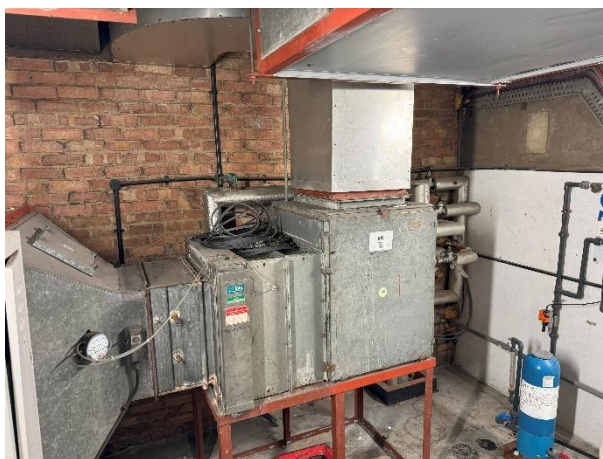
ME8

Due to the size of the unit, it is not economical to refurbish therefore we would recommend replacing the unit in its entirety with a new twin extract unit containing energy efficient direct drive EC plug fans.

Due to the size of the unit, it is not economical to refurbish therefore we would recommend replacing the unit in its entirety with a new supply unit containing energy efficient direct drive EC plug fans.

- Replace both the AHUs with new energy efficient versions c/w standalone controls.
- The new supply unit to contain an electric heater battery to negate the heating requirement from the boilers.
