AHU Condition Report

The National Maritime College of Ireland (NMCI)

Reference: Q1715/NMCI/04.05.2025

Air Handling Unit Condition Report

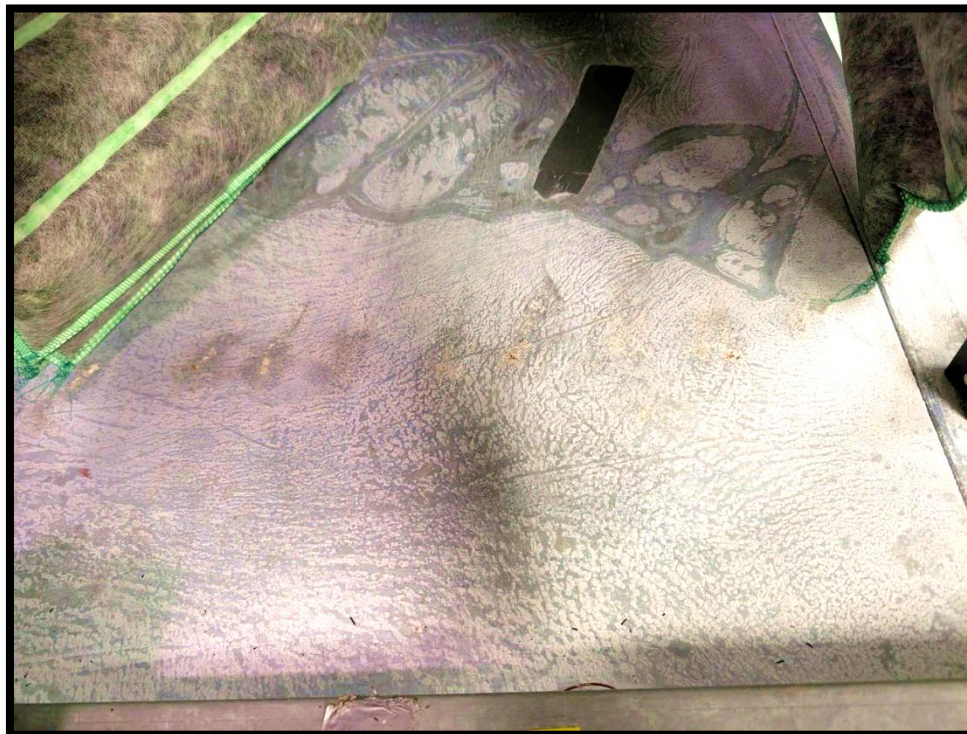
Supply Fan Section Floor Debris/Corrosion

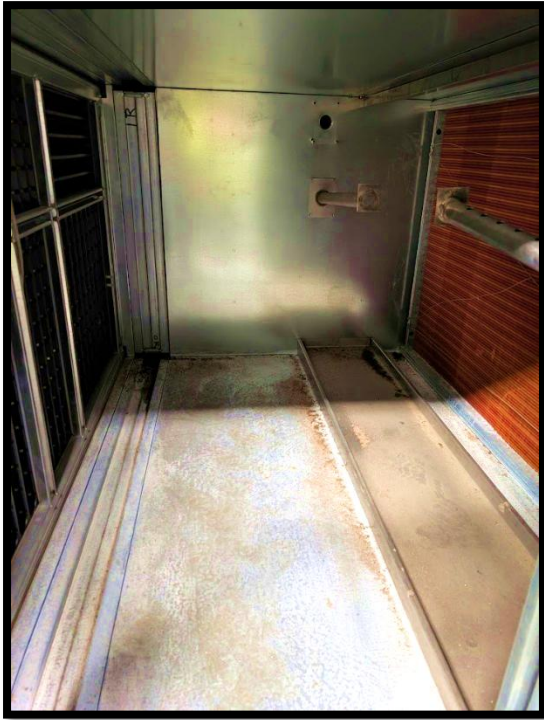
Humidifier Section Corrosion

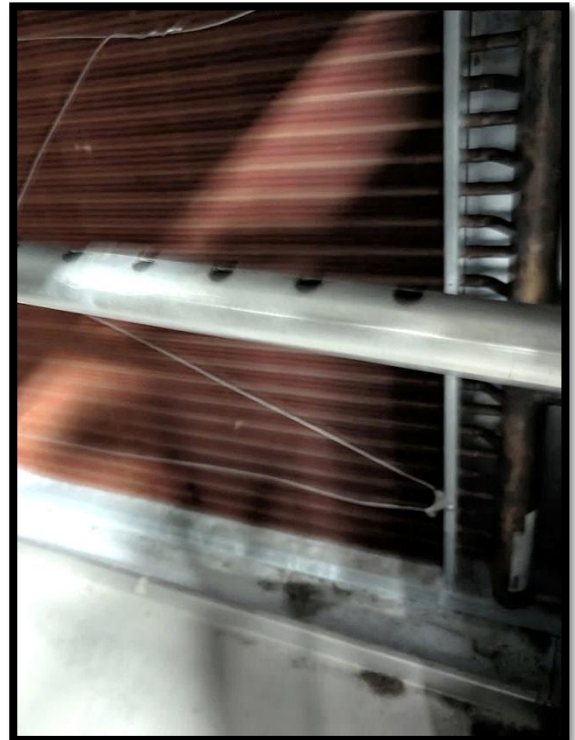
Heating Coil Rusting

- Replace 52.2 kW coil showing fin brittleness and capacity loss.
- Upgrade to reduce energy use and maintain heating reliability.

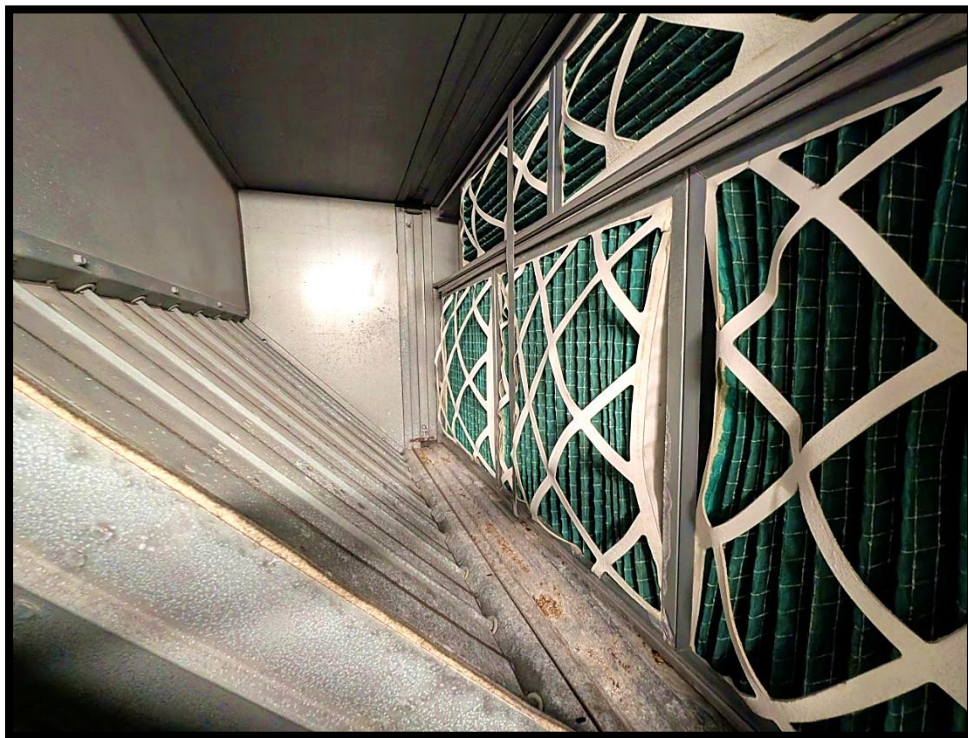
Exhaust Filter Section Collapse/Corrosion

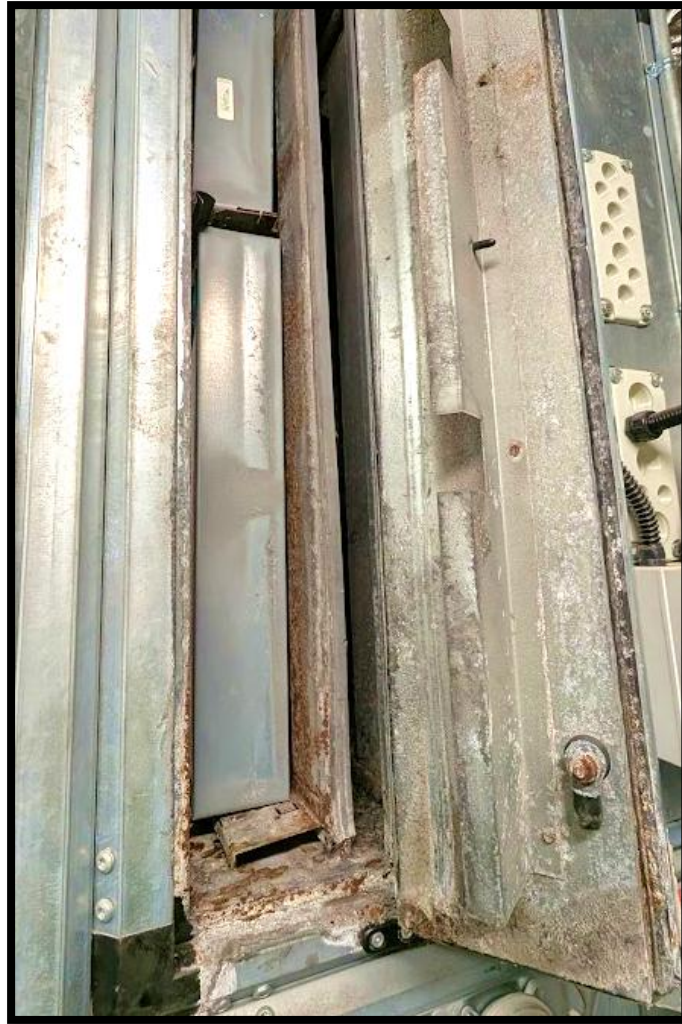
Intake Filter Section Collapse/Corrosion

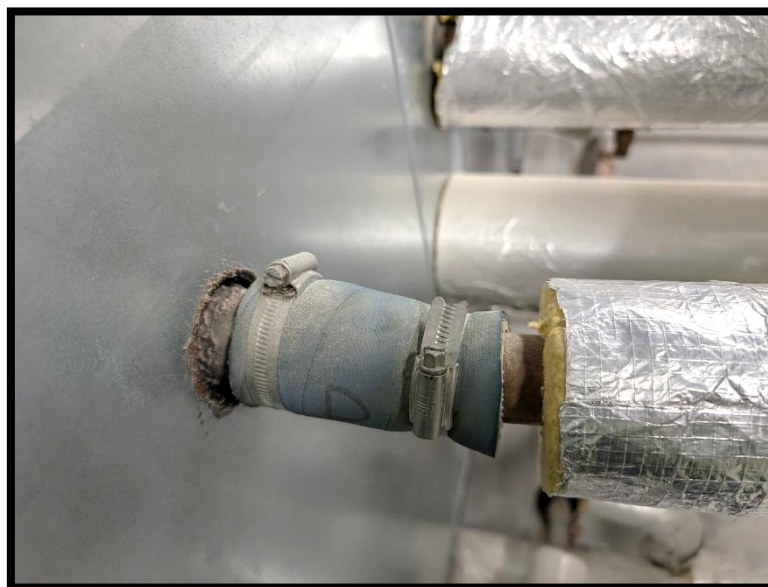
Missing Flange - Air Leak

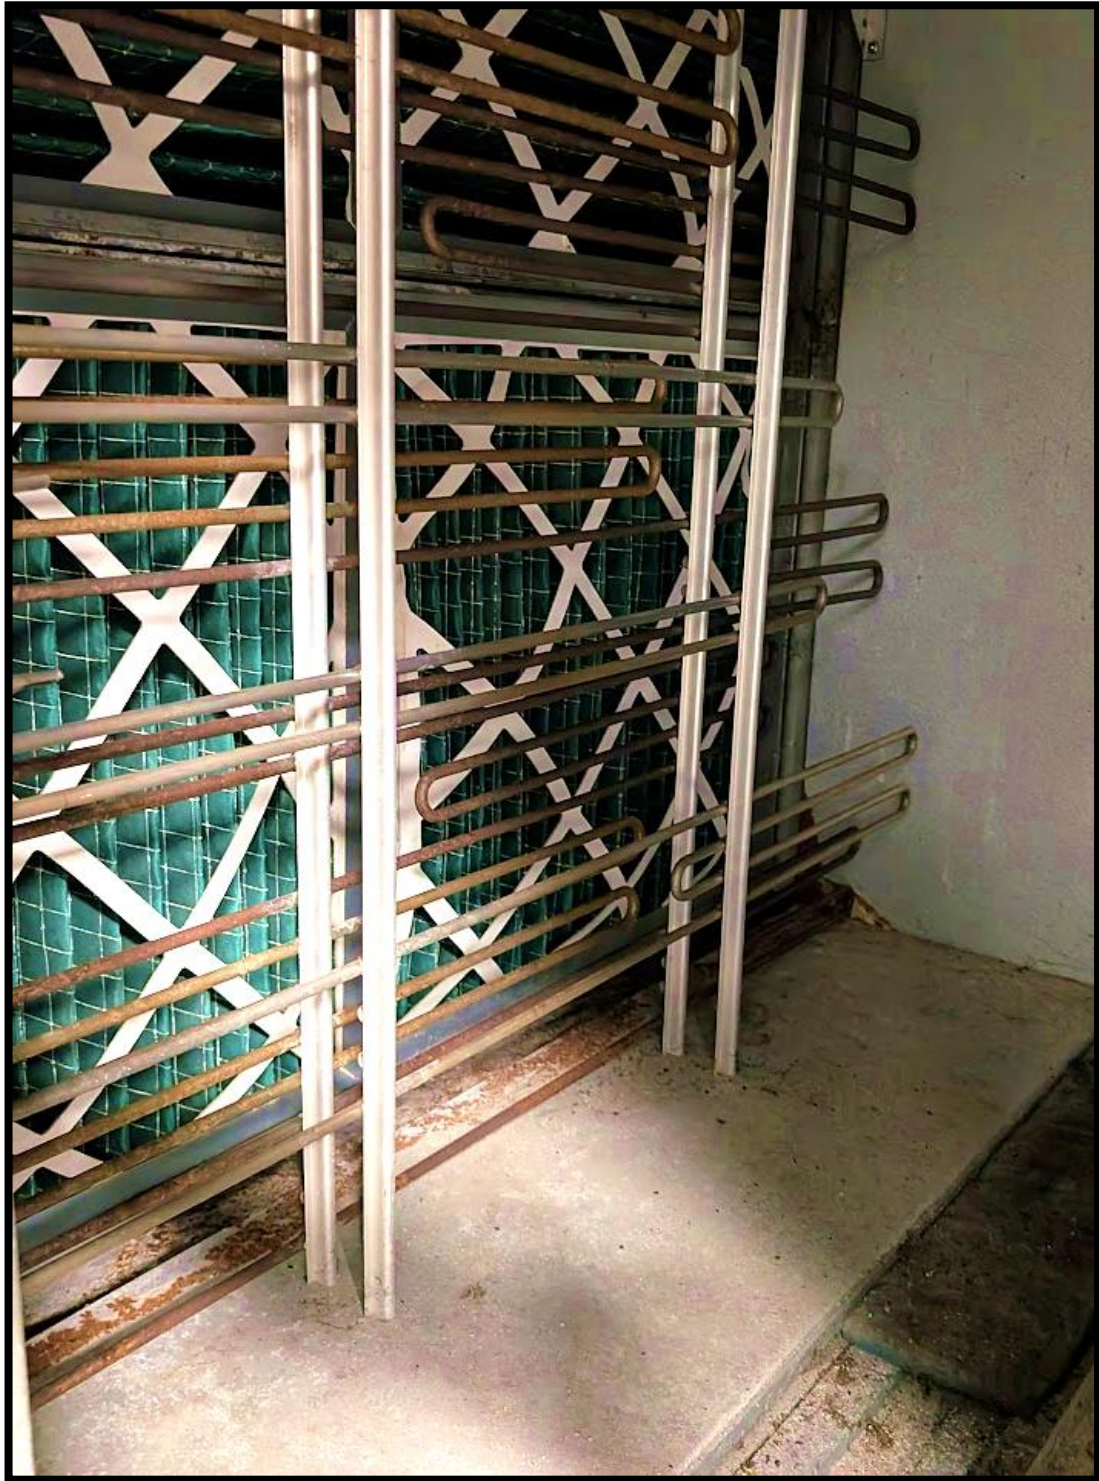
Electric Heater Battery Corroded and Located 150mm From Panel Filters.

(This applies to all AHUs)

- Replace the EHB with a modern, energy-efficient equivalent.
- Reconfigure panel layout to provide ≥ 300 mm clearance from filters, as per best practice.
- Install non-combustible filters or thermal protection if clearance cannot be achieved.

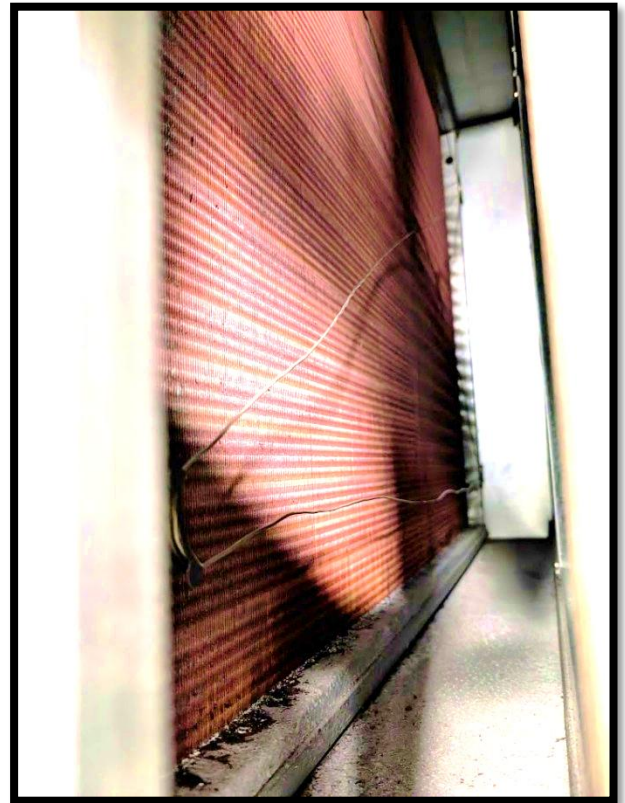
Brittle Corroded Heating Coil

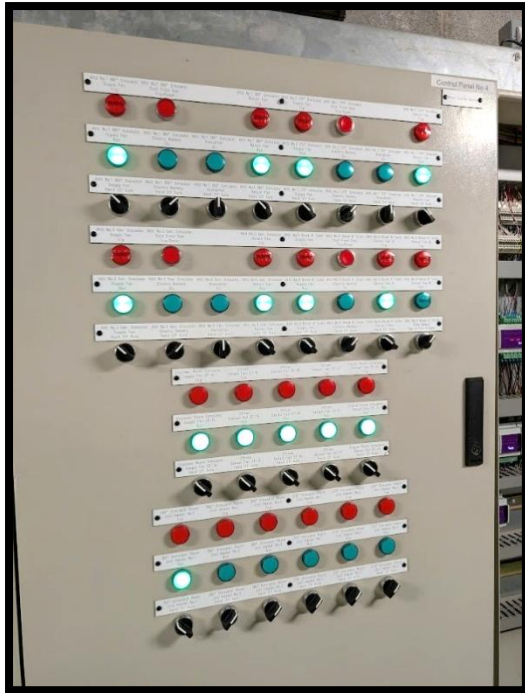
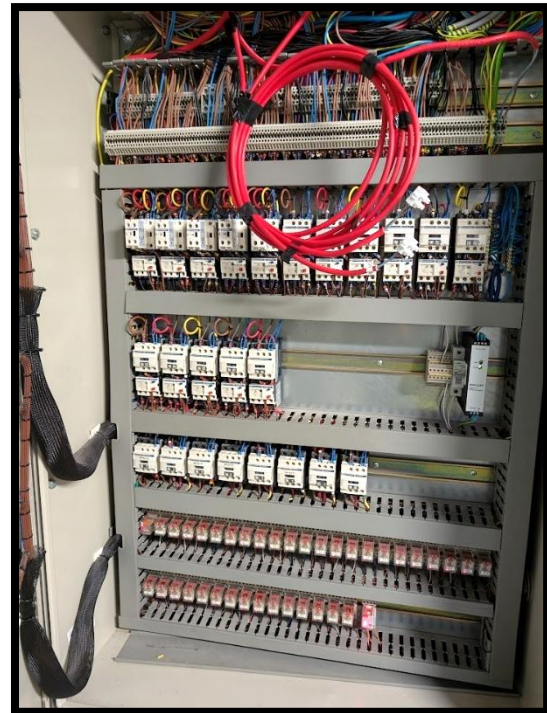
Control Panel

The current **BMS panel** does not appear to support fan speed modulation based on key parameters such as temperature, CO₂ levels, airflow and other set points.

We recommend a detailed BMS survey be undertaken to assess upgrade potential. Significant energy savings and operational efficiencies could be achieved through the integration of intelligent control strategies, including demand-based ventilation and control.

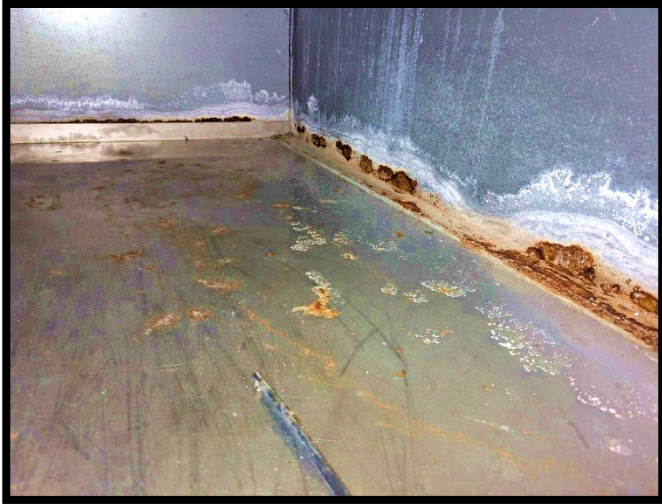
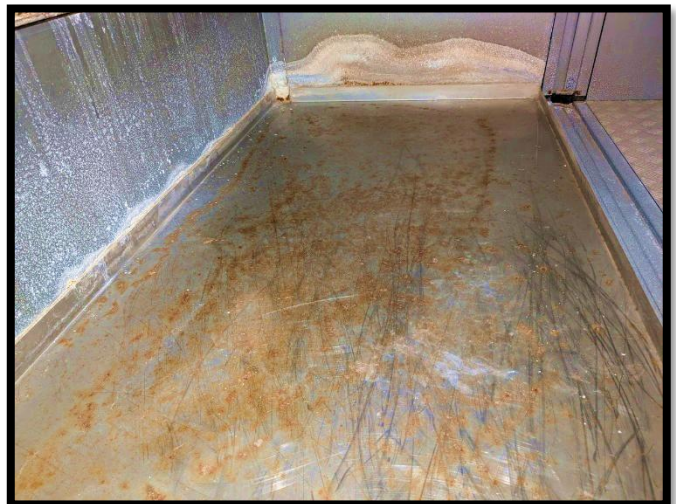
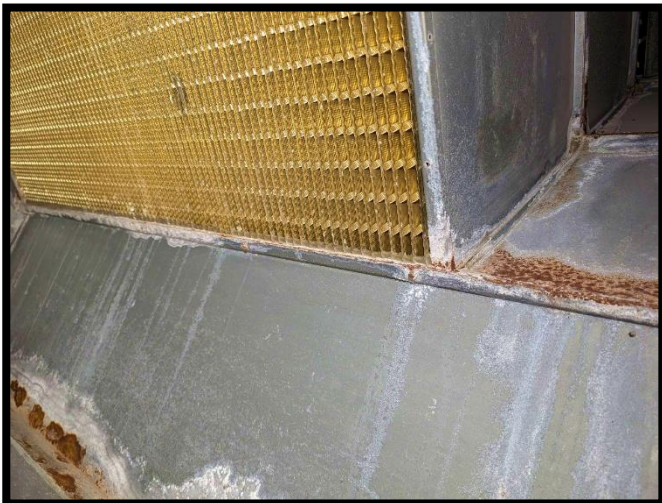
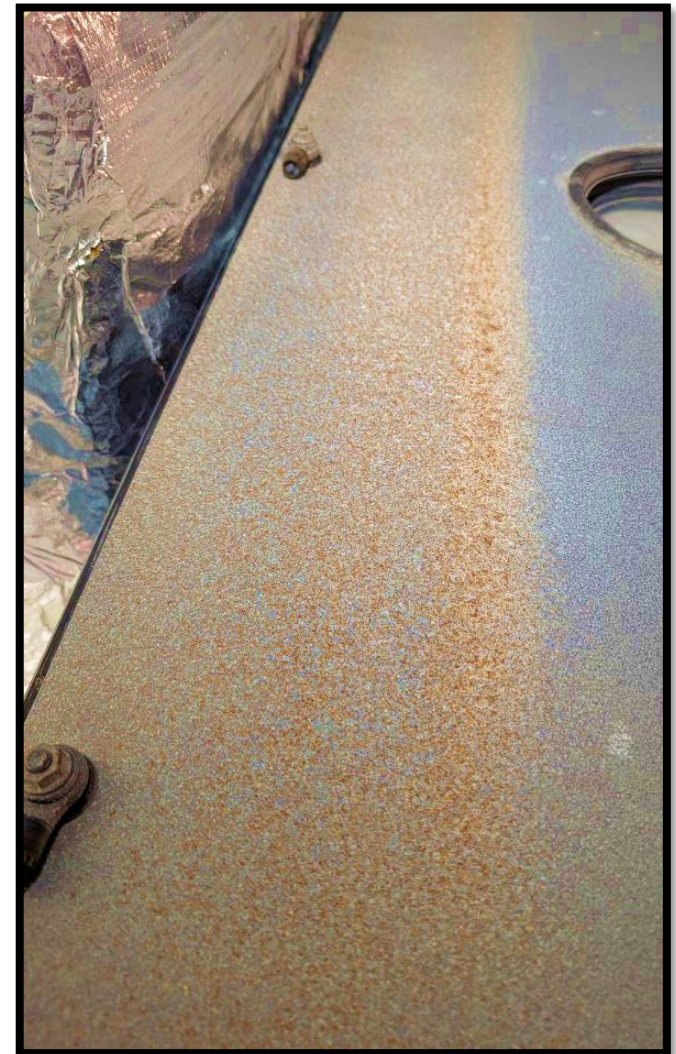
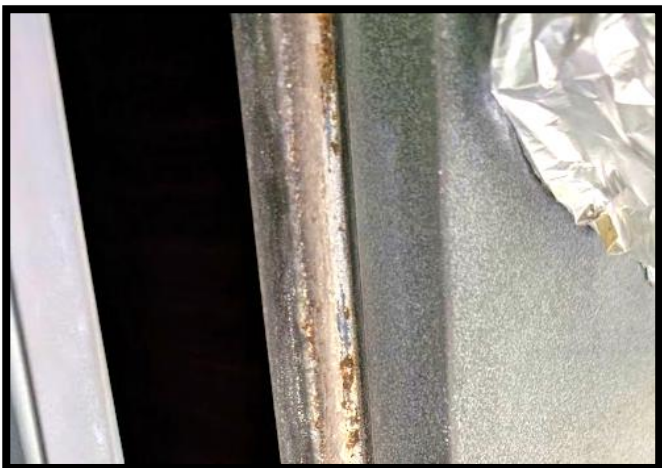
Corrosion Throughout

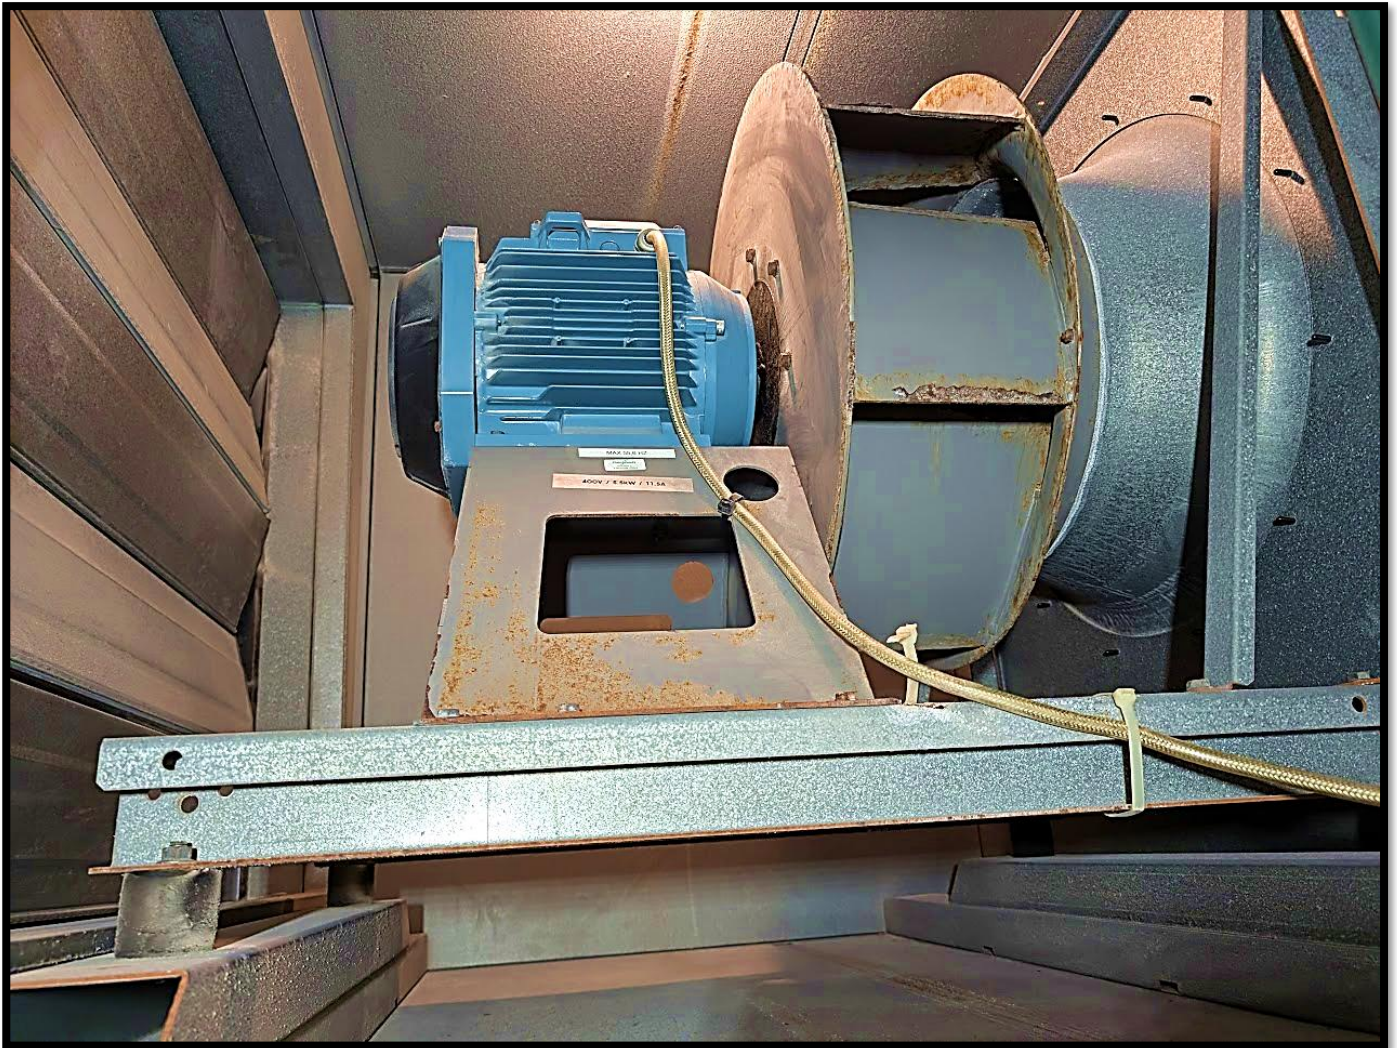
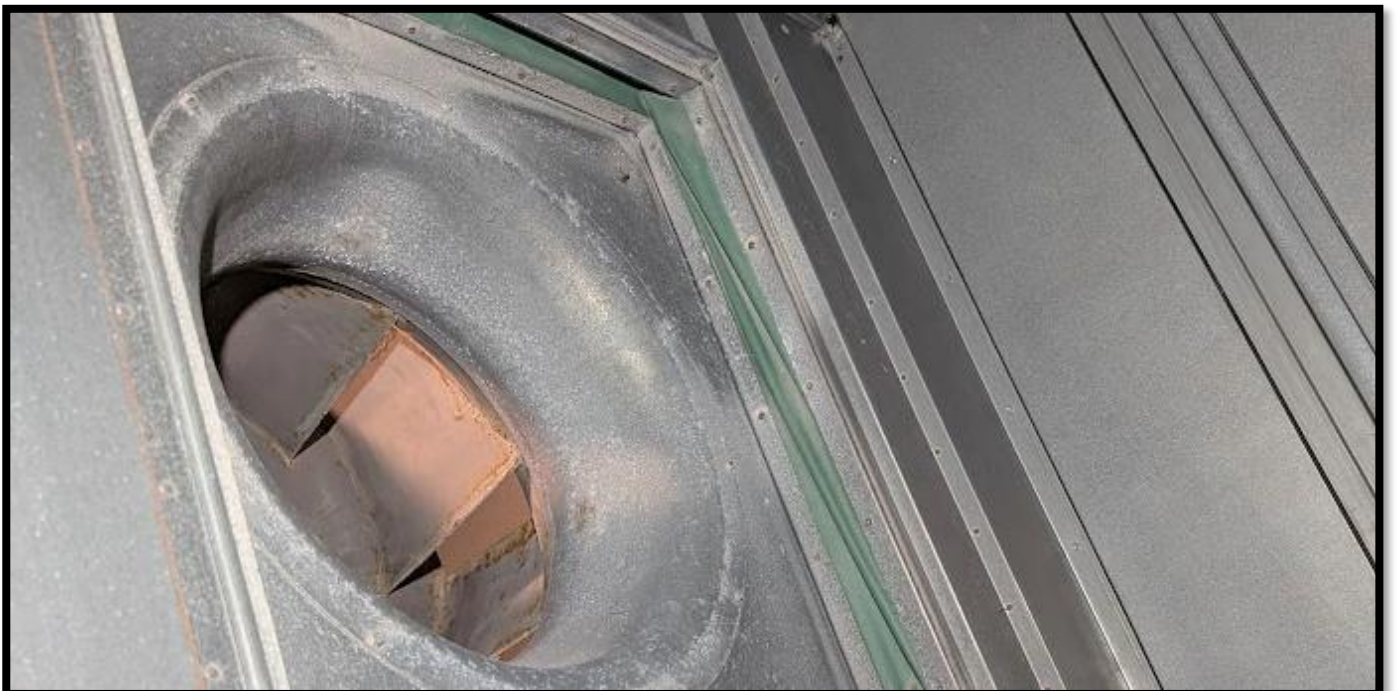
Corrosion Throughout Both Fan Sections and Directly Within Fan Impeller

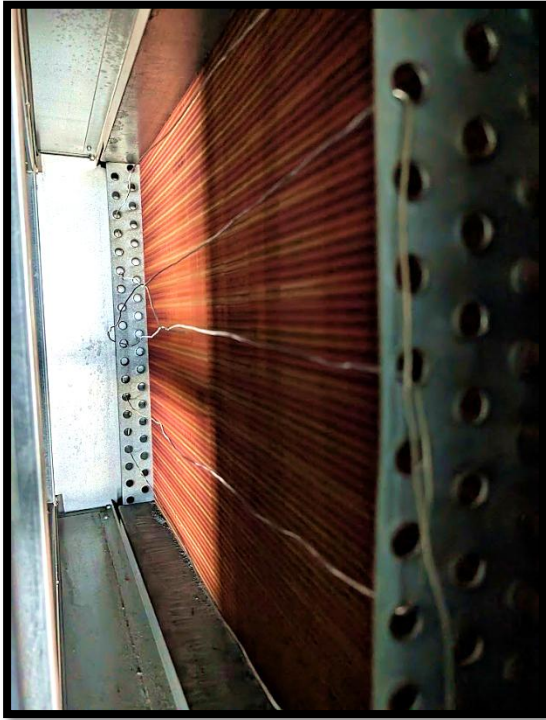
Heating Coil Corrosion

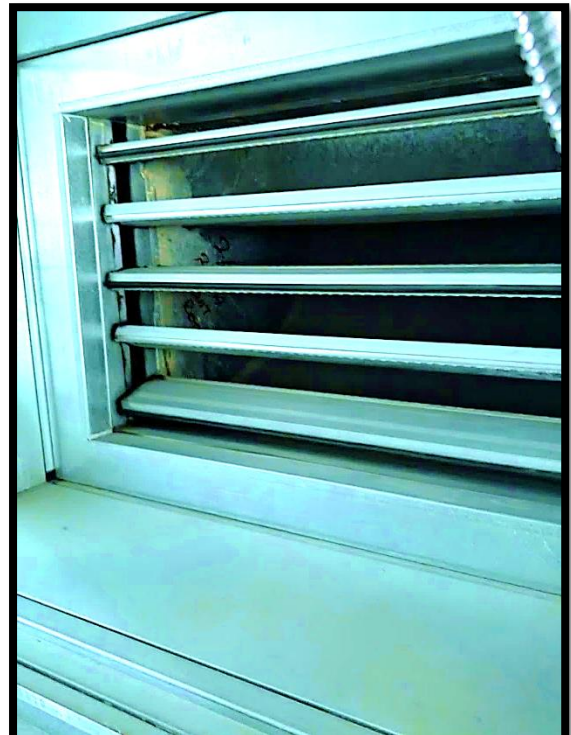
Air Off Damper Side – unable to access air on, signs of debris/corrosion through dampers

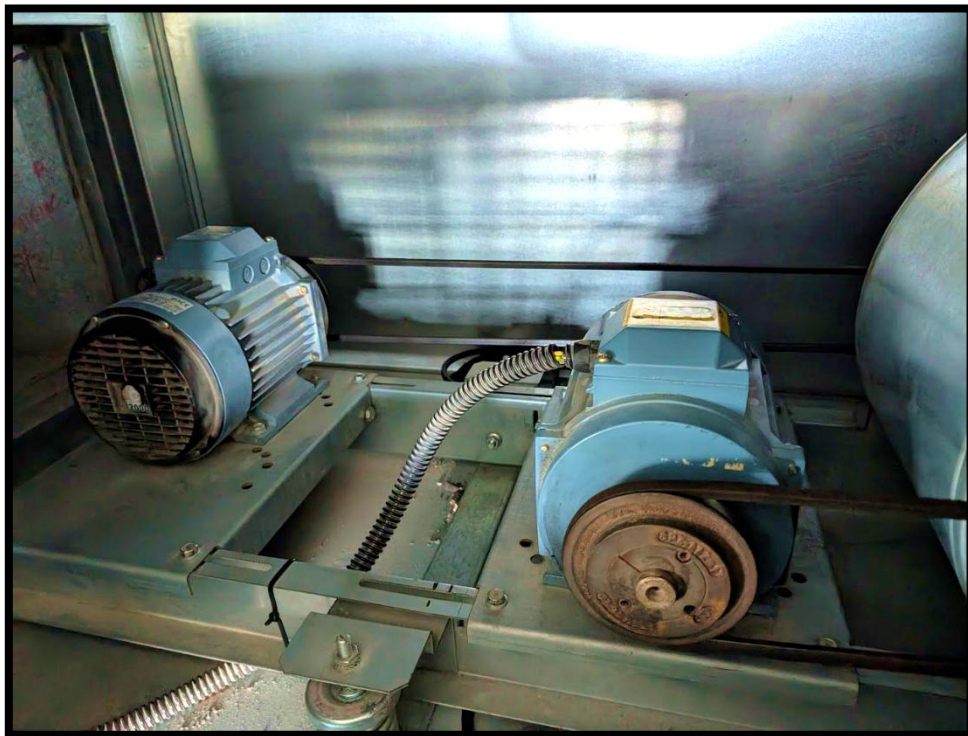
Exhaust Fan Motor Corrosion

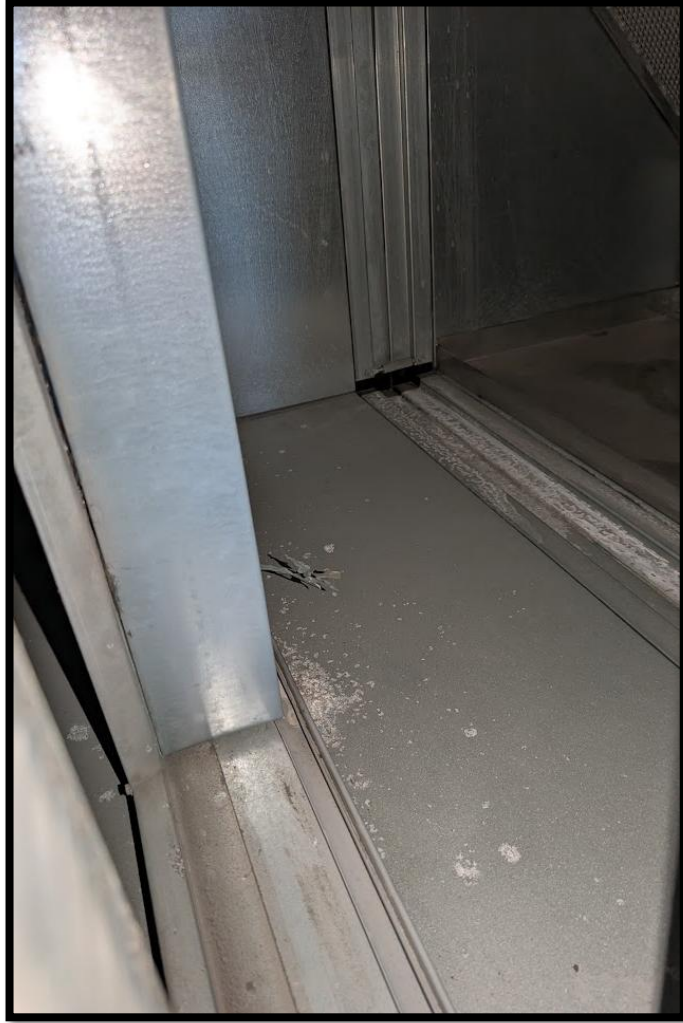
Intake Filter Section debris/Corrosion

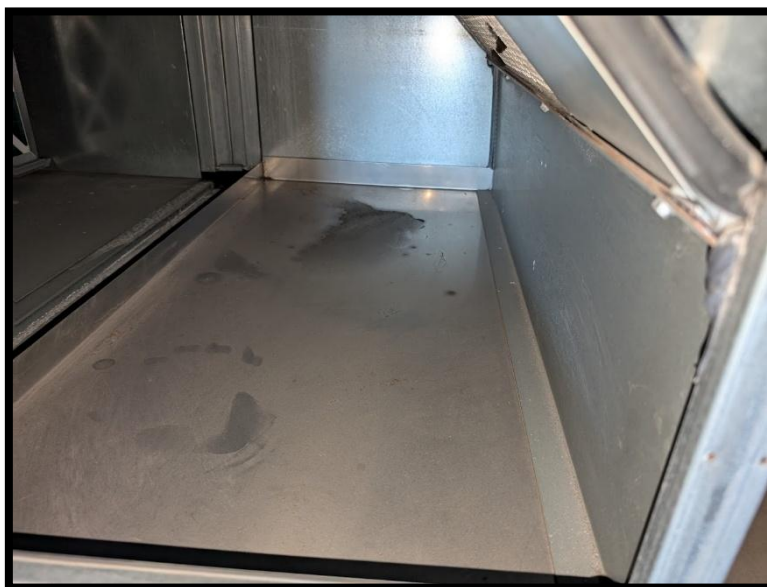
Debris Build Up Air Off Side Heat Exchanger

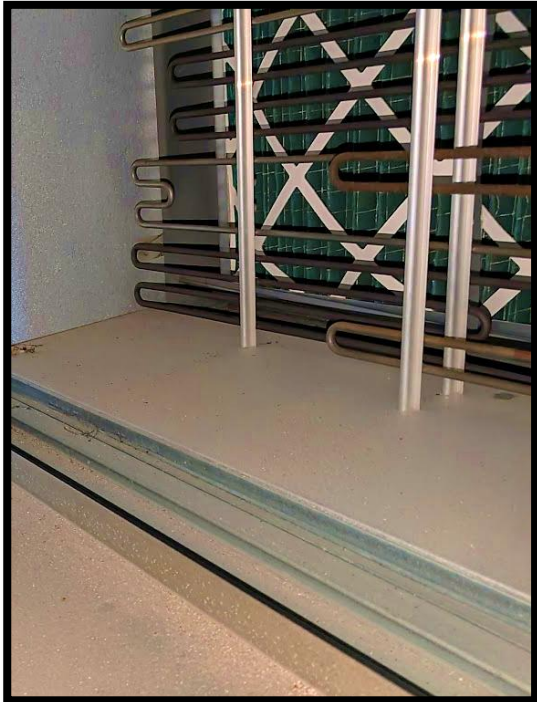
Electric Heater Battery Corroded

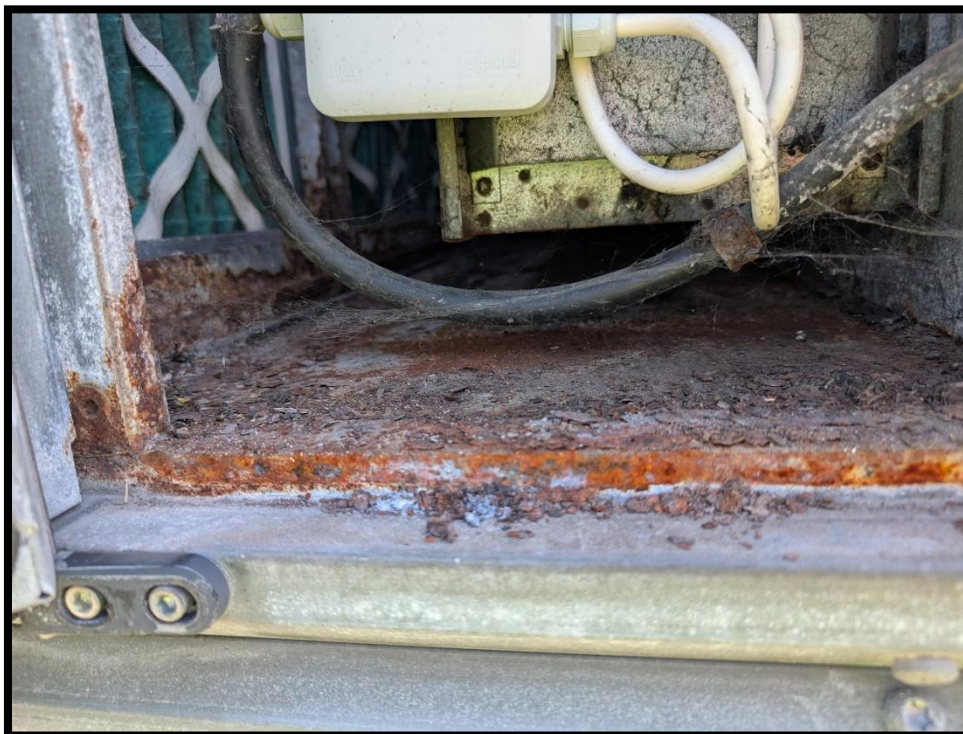
Intake Debris/Corrosion

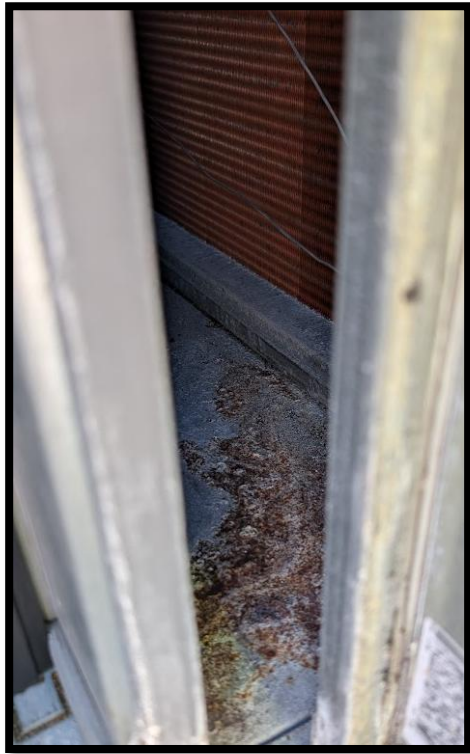
Heating Coil Corrosion

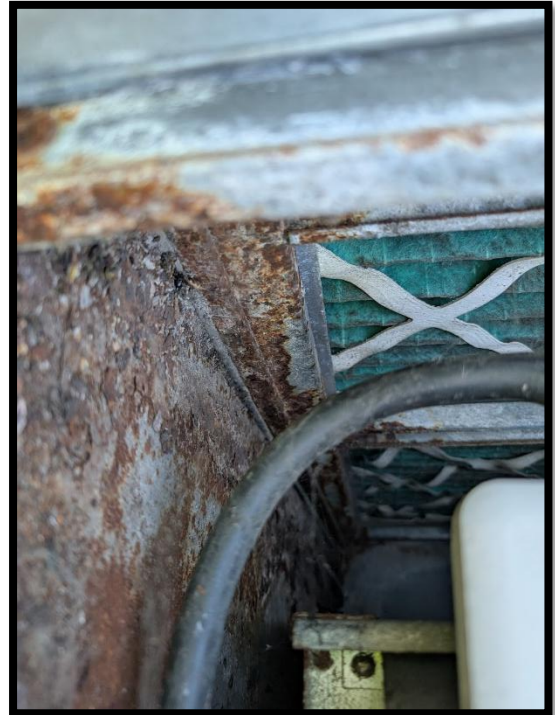
Intake Section Corrosion

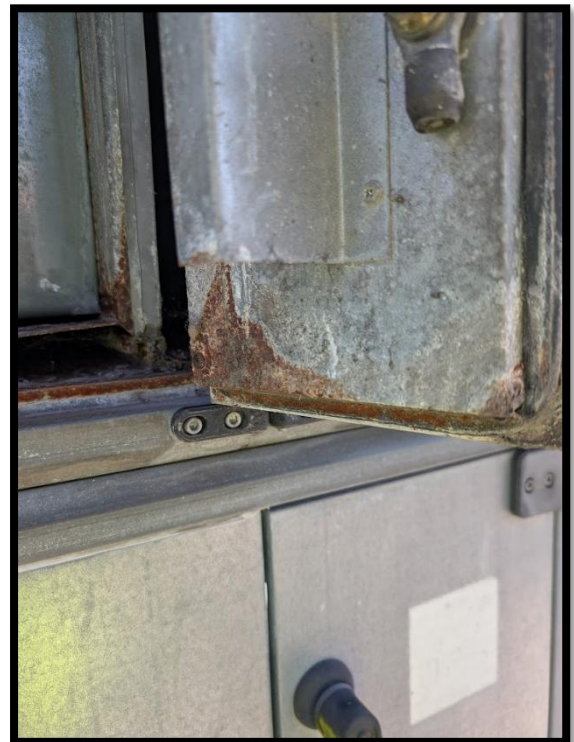
Rusting of Access Panels

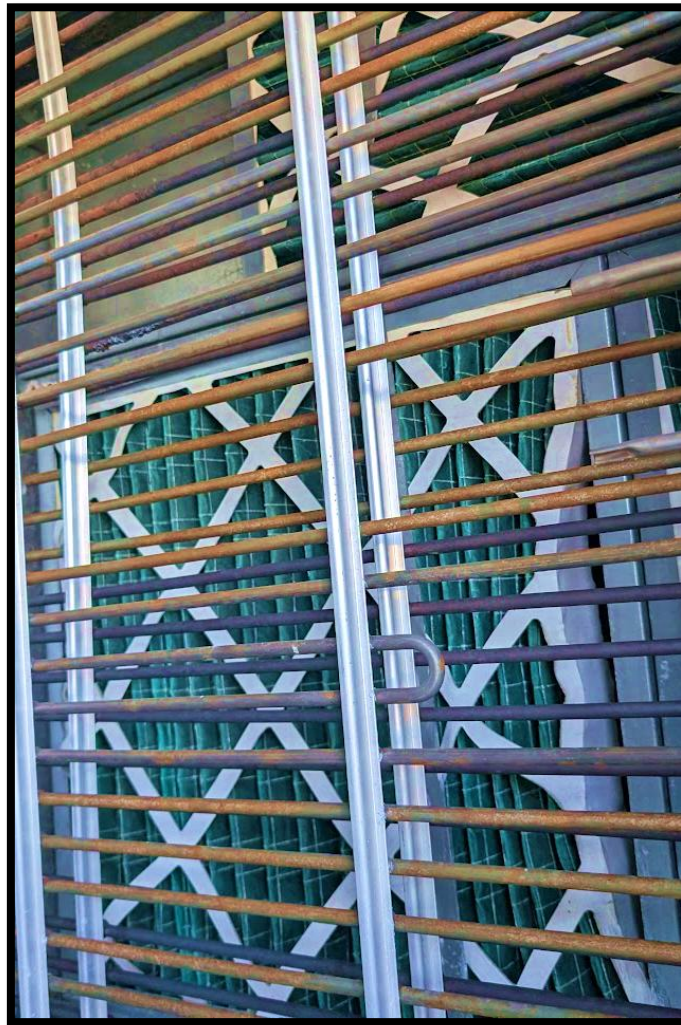
Electric Heater Battery Corrosion

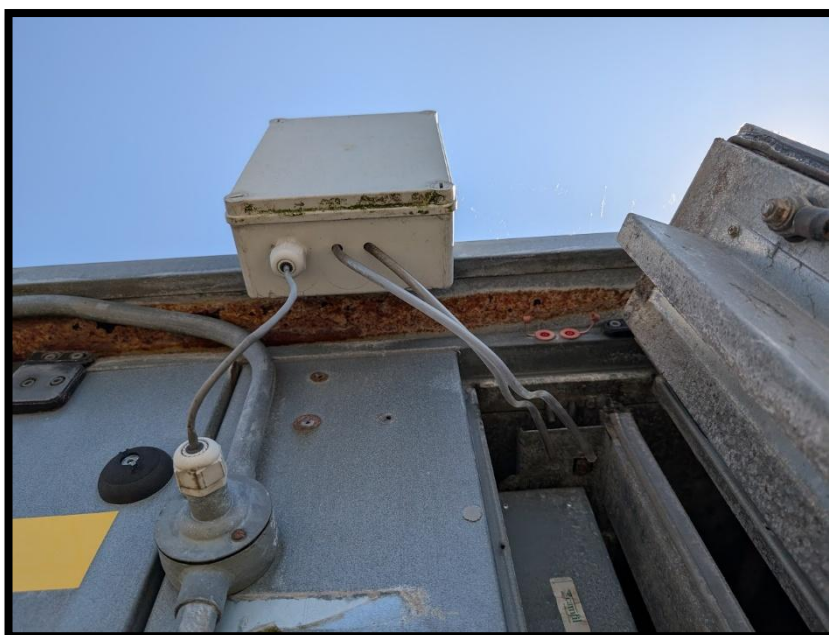
Roof Deterioration/Corrosion

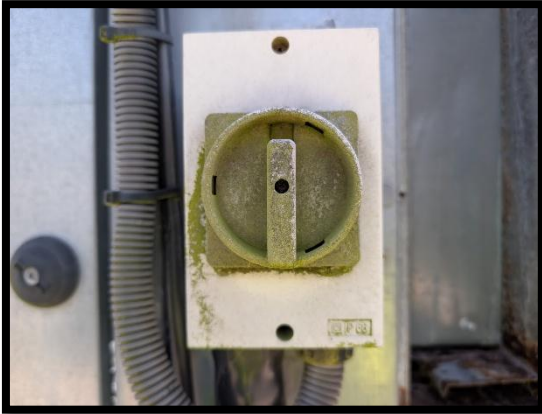
Weathered Isolator

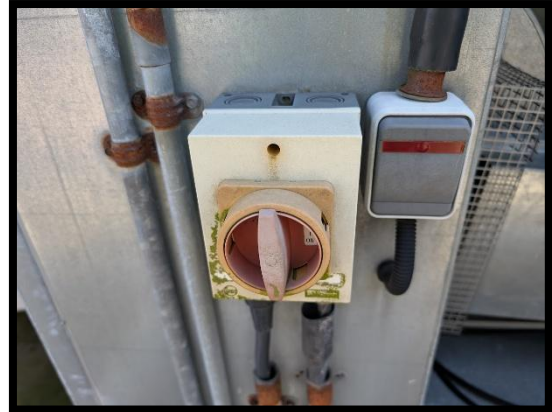
Corroded Containment

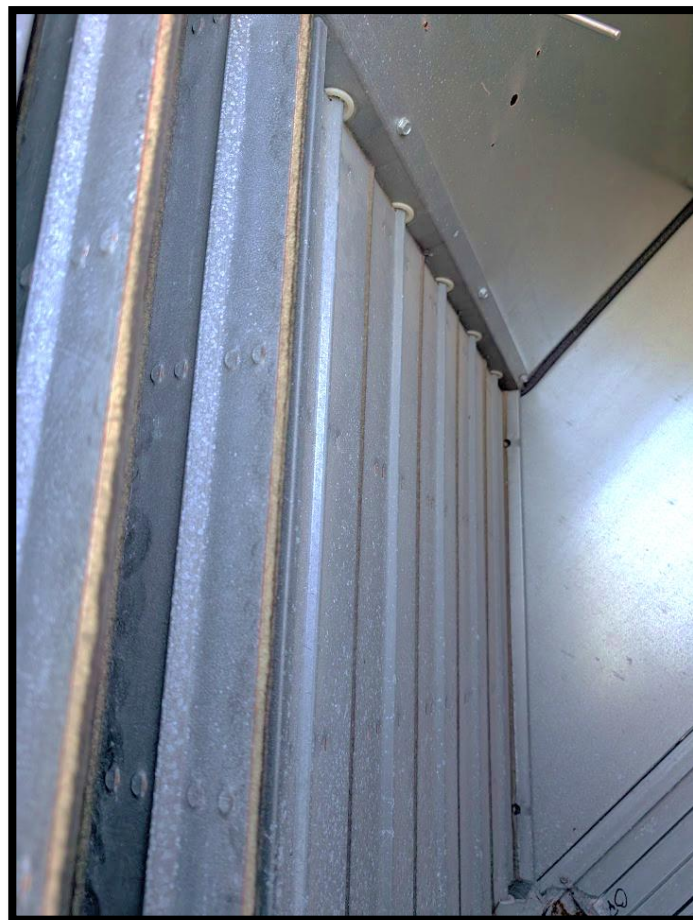
Microbial Growth on Heat Exchanger

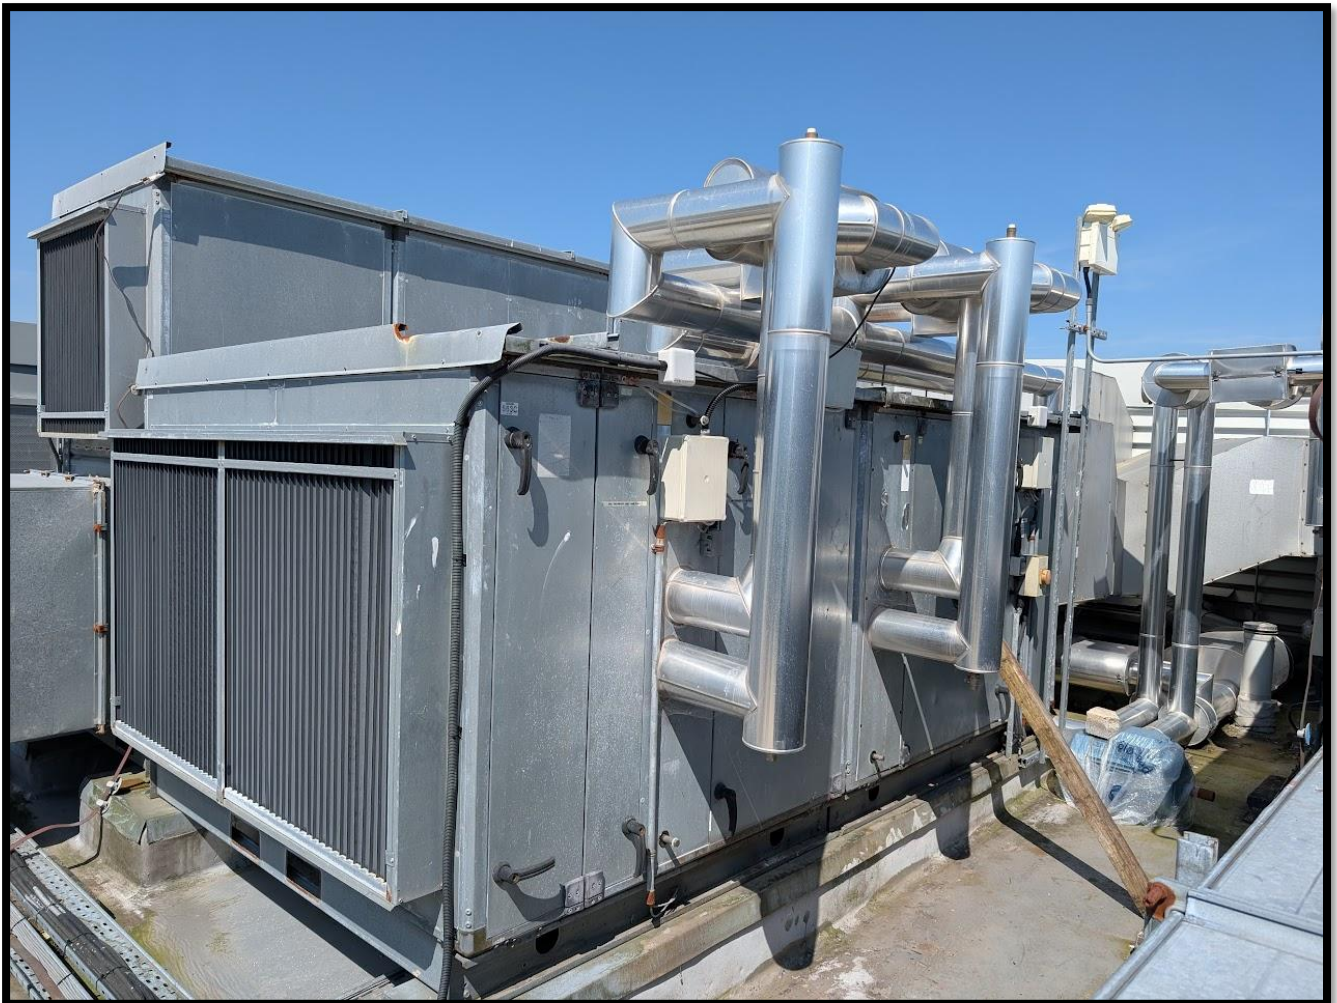
Door Unsecured

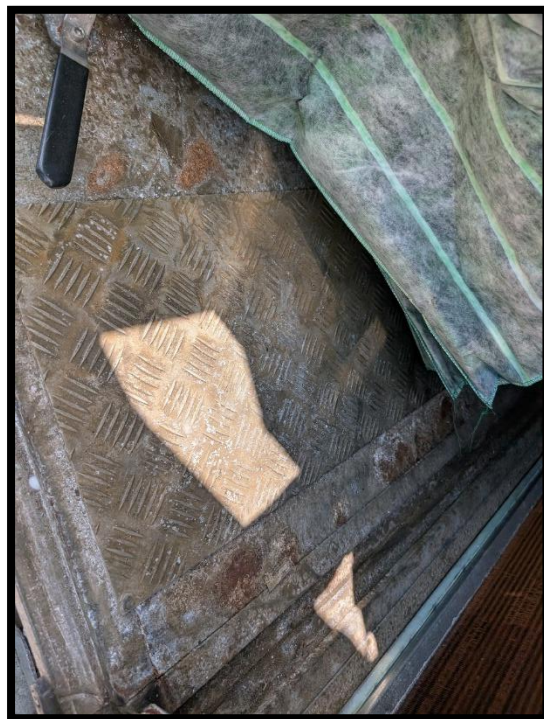
Fan Section Corrosion

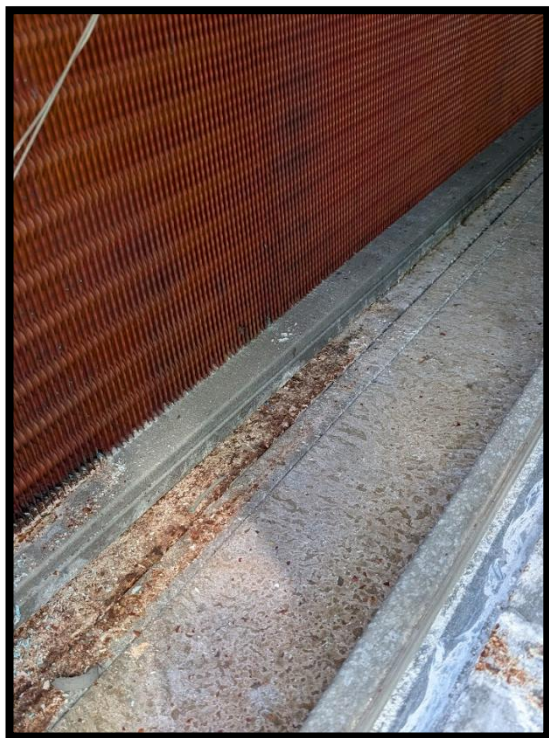
Heating Coil Corrosion

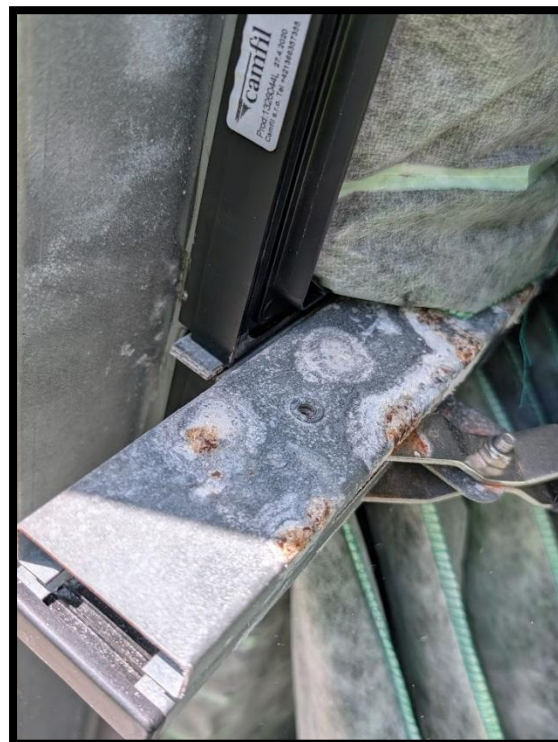
Corroded Filter Frames

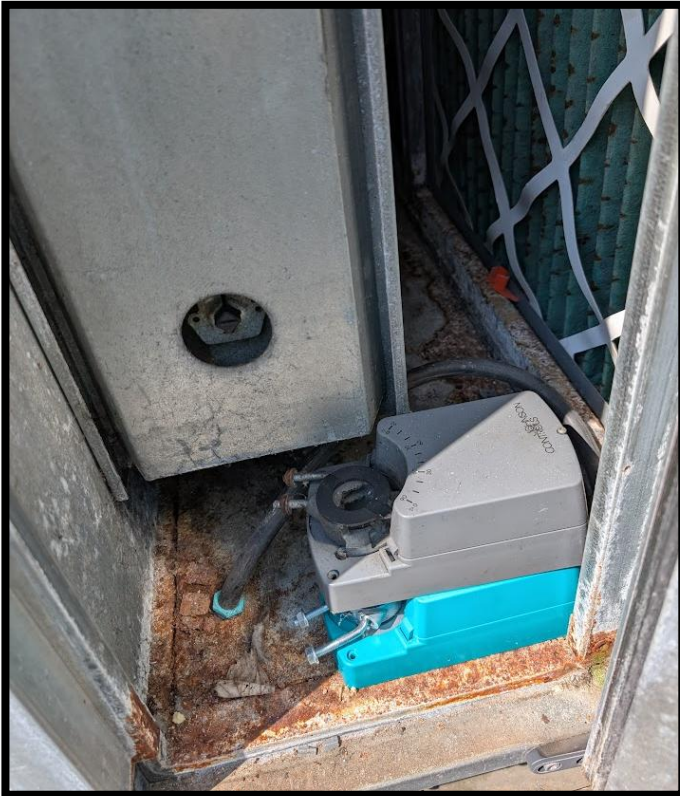
Discharge Section Corroded. Damper Spindle Snapped

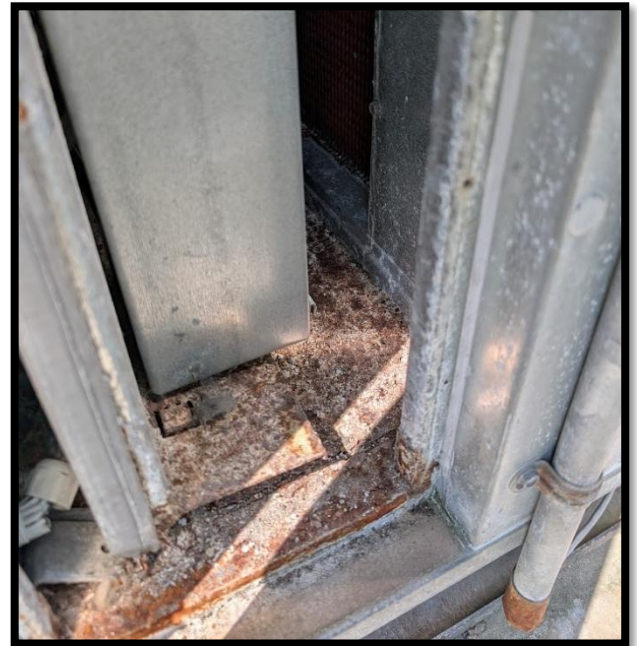
Intake Section Corroded

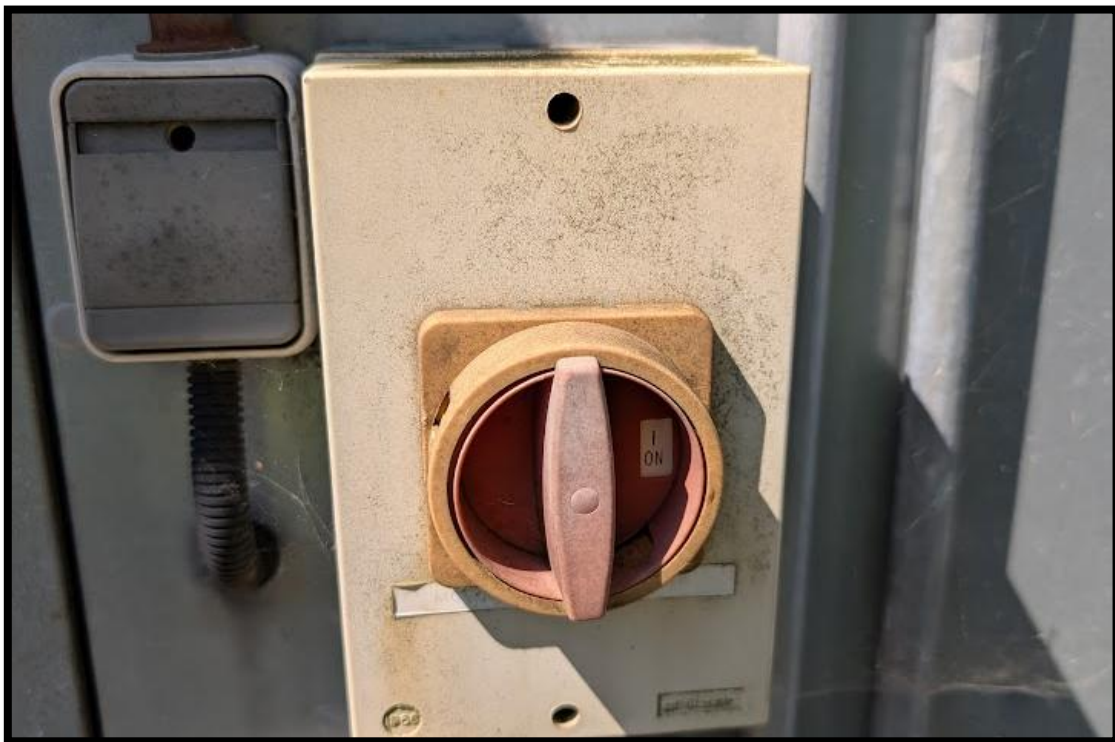
Weathered Electrical Containment
