AHU Condition Report

The National Maritime College of Ireland (NMCI)

Reference: Q1715/NMCI/04.05.2025

Air Handling Unit Condition Report

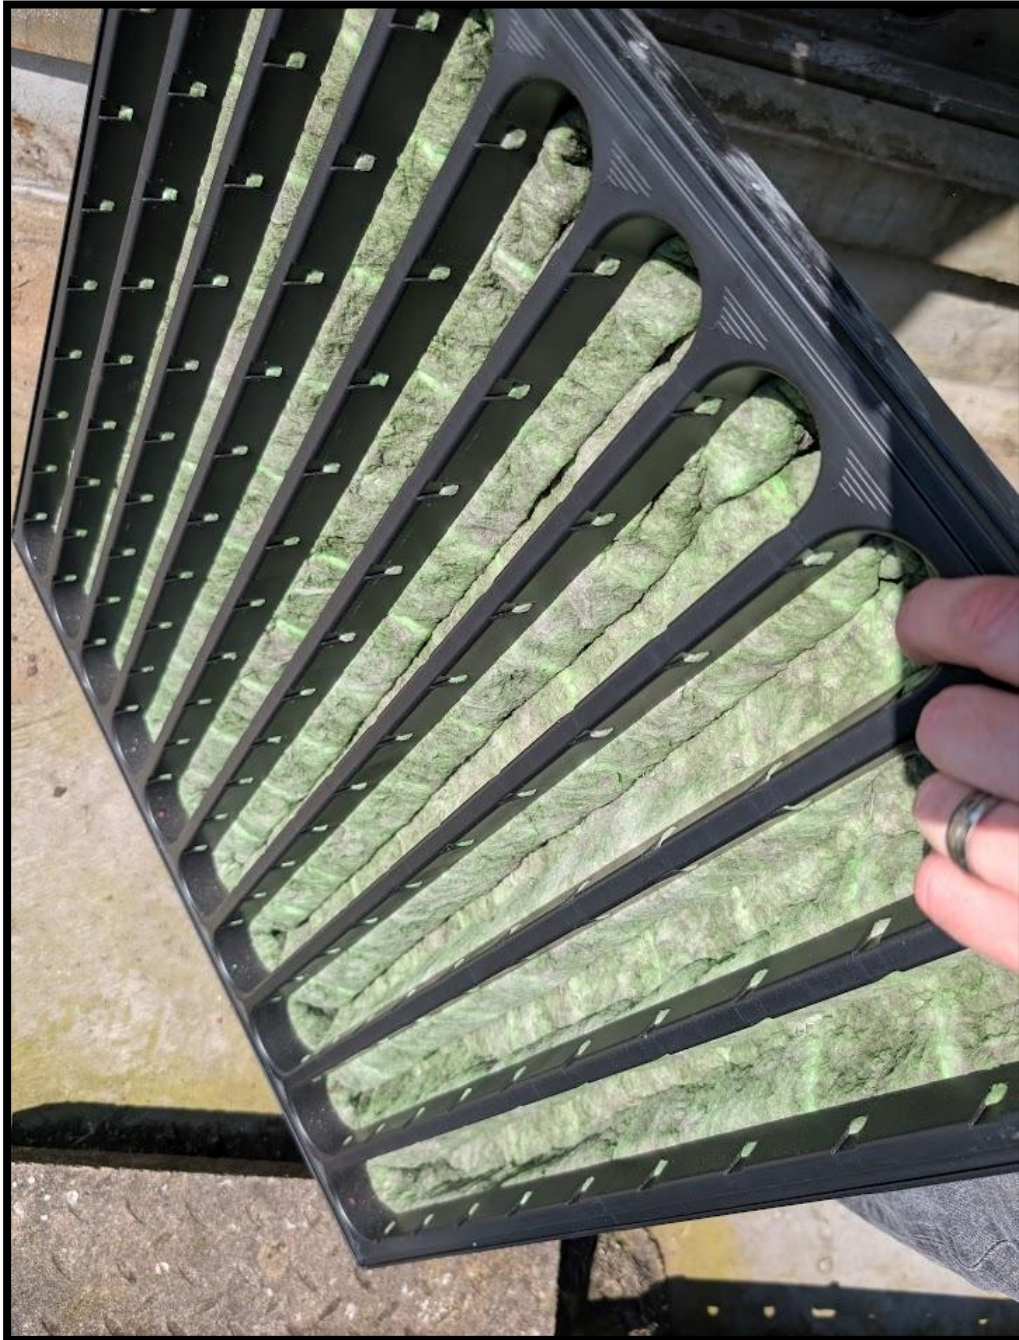
Signs of Water Logging in Bag Filters

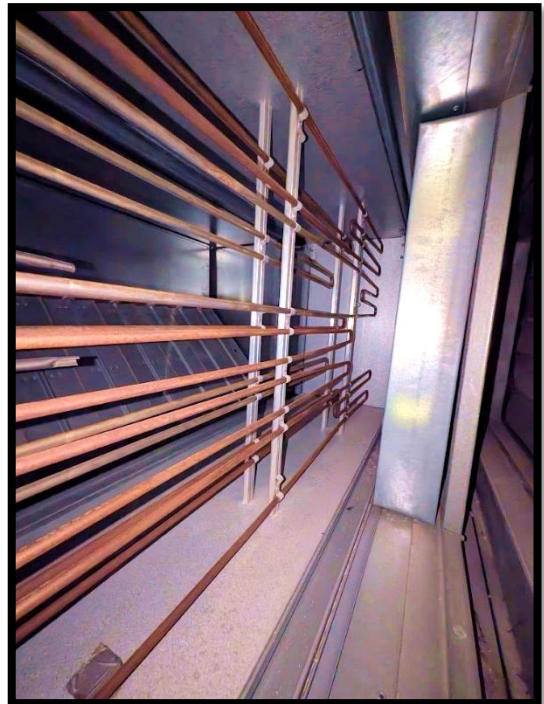
Corroded EHB

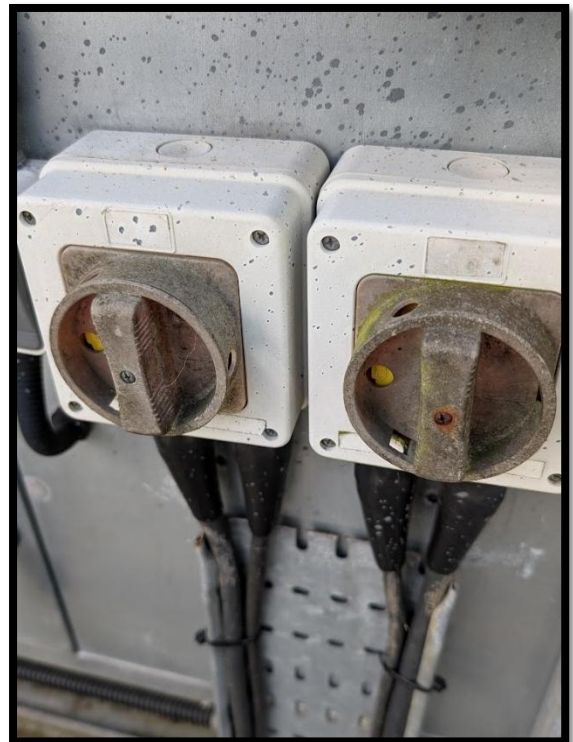
Weathered Isolators
