AHU Condition Report

Spire Montefiore

Air Handling Unit 8 - Condition Report

Reference: Q1657/ACVR Services Ltd/17.07.2024

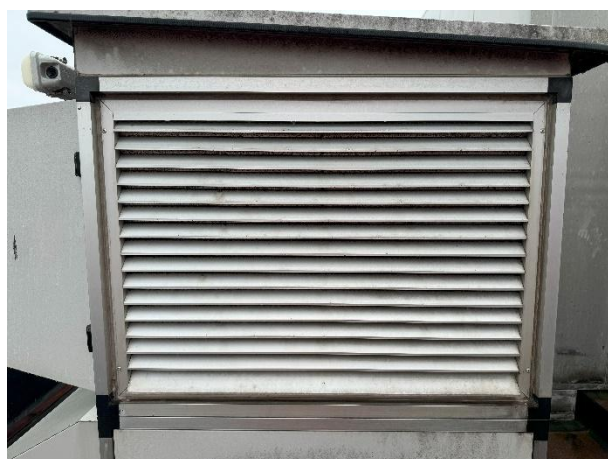
The fresh air inlet for the AHU is an external weather louvre with bird mesh affixed to the rear. The louvre seemed in reasonable condition with a clean required on the external face and clean of the bird mesh. A fresh air inlet damper is installed immediately behind the intake louvre. The damper utilises plastic cogs and also has the damper actuator within the airstream.

Fresh air inlet louvre

- Clean the fresh air inlet louvre and associated bird mesh.
- Replace the fresh air inlet damper and exhaust damper with new metal linkage dampers.
- New damper actuators to be out of air stream.

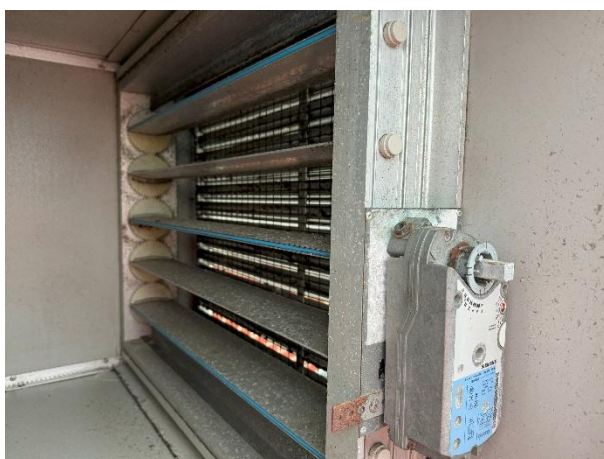
Fresh air inlet damper and actuator

The fresh air inlet, exhaust, and face and bypass damper currently utilise plastic cogs. They should therefore be replaced with new dampers utilising metal linkages to operate. New damper actuators should be installed out of air stream. There are no supply air dampers or return air dampers fitted. It is not possible to replace the face and bypass damper on the plate heat exchanger without replacing the plate heat exchanger itself. The drain tray for the plate heat exchanger is not removable, however, there is plenty of access to maintain the drain tray even with the exhaust attenuator in proximity.

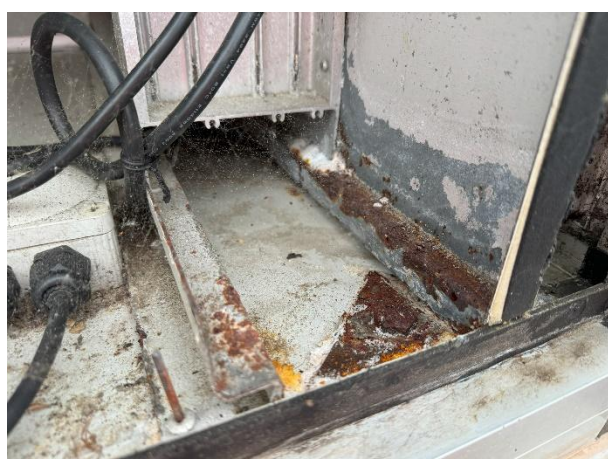
Corrosion in fresh air intake section

- Clean the internal surfaces of the unit throughout.
- Sand and treat the corroded surfaces of the unit throughout.
- Replace the corroded terminal box.

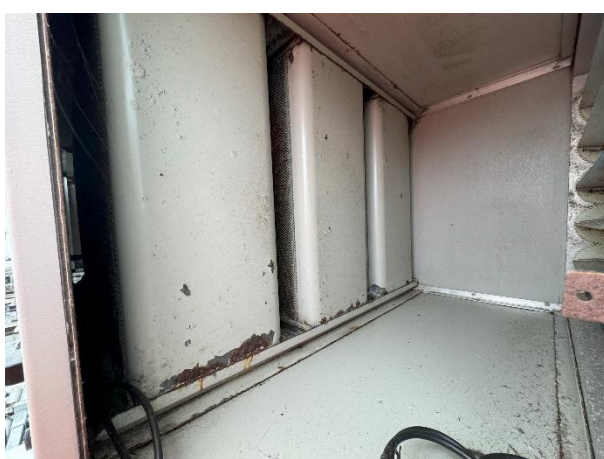
An attenuator is installed after the fresh air inlet damper and has suffered from corrosion over the years. Upon removal of the access panel for the attenuator, it was excessively dirty which is impacting performance.

Air on side of attenuator in supply air stream

- Supply and install new supply air damper and return air dampers.
- Replace the corroded supply air stream attenuator and extract air stream attenuator.

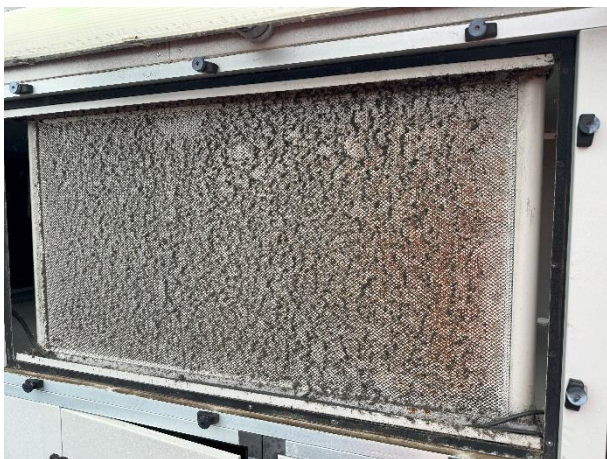
Attenuator in supply air stream

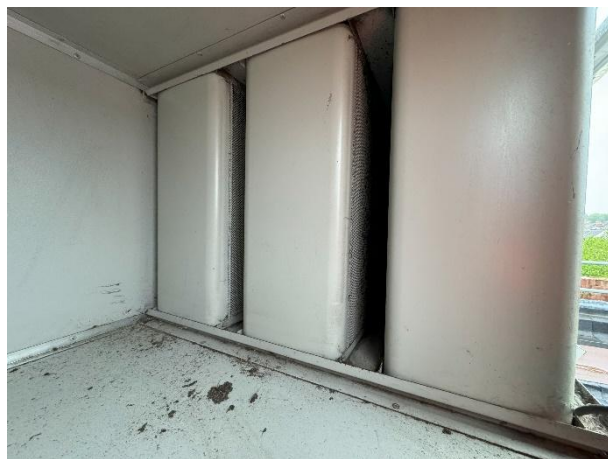
Air off side of attenuator in supply air stream

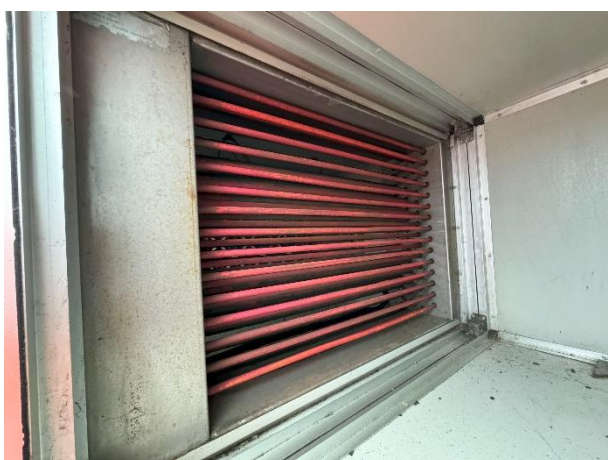
The bare tube frost coil is in reasonable condition and has a stainless-steel casework construction designed to heat from -4°C to 5°C using 80°C/60°C flow and return temperatures. There is a build-up of dirt within the section after the frost coil immediately before the panel filters.

Frost coil

- Retrofit handles onto the removable access panels for the attenuators.
- Replace the frost coil to suit the new air volume.
- Replace the panel and bag filters throughout the AHU.

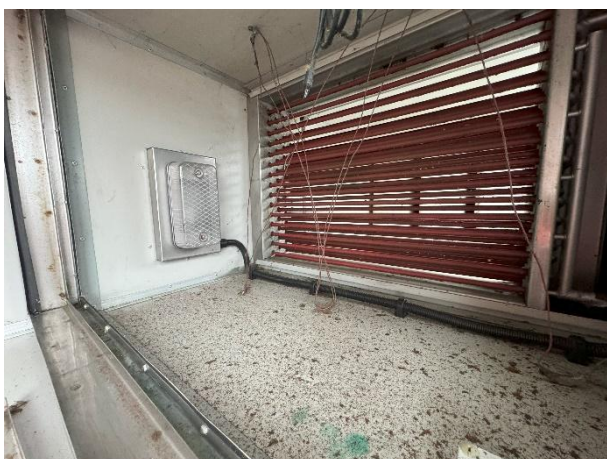
Plenum between frost coil and panel filters

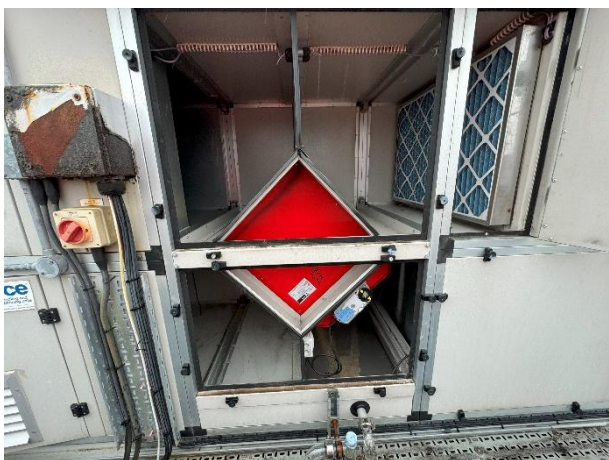
The AHU contains a plate heat exchanger as means of heat recovery which had a dry efficiency of 47.3% at design stage, over the years this efficiency level will have decreased due to dirt build up within the matrix of the plate heat exchanger. Current ErP regulations require a 73% efficient heat recovery device in supply and extract air handling units. The plate heat exchanger is corrosion protected to suit the coastal environment of the site. The face and bypass damper for the plate heat exchanger uses plastic cogs and also has the damper actuator within the airstream.

Overview of plate heat exchanger

- Replace the plate heat exchanger and associated face and bypass damper. The new PHE will be epoxy coated with a metal linkage face and bypass damper.

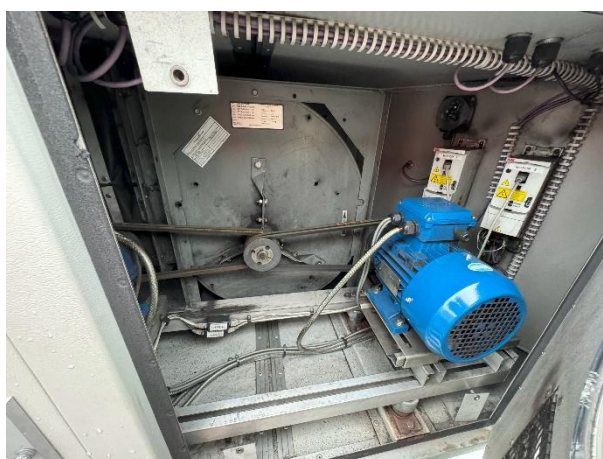
Immediately after the plate heat exchanger is a SISW belt driven fan with run and standby motors installed out of the air stream. Both motors were belted up to the fan pulley and inverters are installed within the fan section with keypads installed on the AHU casework secured in weatherproof housings. The drive guard for the supply fan was missing during our survey. We recommend the SISW belt driven fan and motors are upgraded to run and standby energy efficient direct drive EC plug fans. A critical spare EC plug fan should be supplied in the unlikely event of failure.

Belt driven SISW supply fan with run and standby motors

- Upgrade the supply and extract belt driven fans to energy efficient direct drive EC plug fans.
- New EC plug fans to come with commando sockets and critical spares.

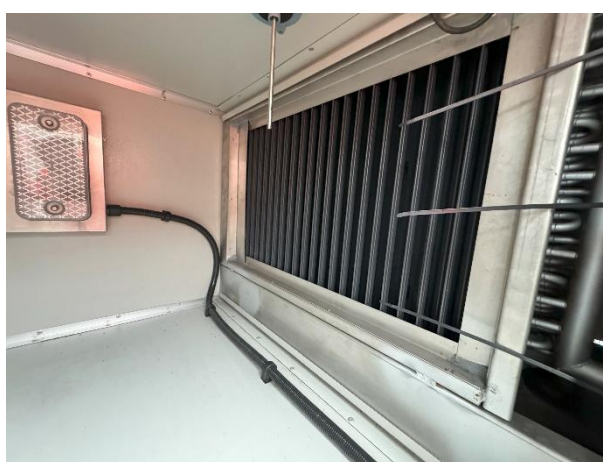
There is an access section between the fan outlet and the face of the cooling coil. The cooling coil is in reasonable condition and was designed to cool from 30°C to 13°C using 7°C/12°C flow and return temperatures and was manufactured with polyester coated aluminium fins and stainless-steel casework. The original design drawing for the AHU states the coil is fitted with a removable stainless-steel drain tray and removable moisture eliminators. However, upon inspection it appears the eliminators do not seem to be the removable type.

Moisture eliminators

The existing CHW cooling coil has fixed moisture eliminators with no access for cleaning therefore the coil should be replaced. The new coil should have a removable stainless-steel drain tray and removable moisture eliminators.

- Plate over the redundant inverter keypads.
- Modify the control panel to suit the new EC plug fans.
- Replace the cooling coil to suit the new air volume. New cooling coil to come with removable eliminators.

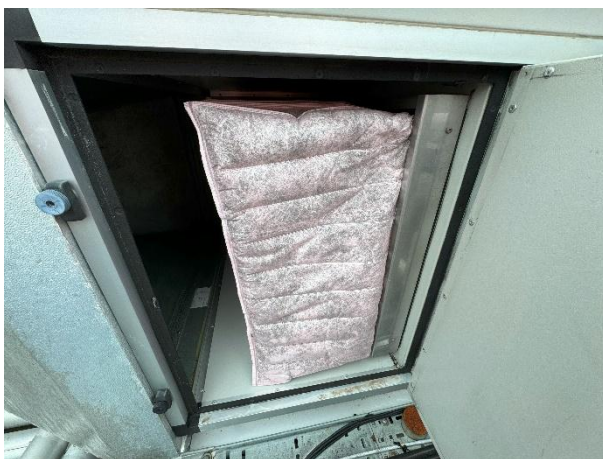
The bag filters are the last component within the AHU on the supply air side. The bag filter frame is a side withdrawal type manufactured from stainless steel. This houses 2no 380mm deep ISO16890 ePM2.5 65% bag filters. It is not possible to retrofit a front withdrawal filter frame in place of the existing side withdrawal frame due to the access constraints of the existing AHU. The way the existing filter frame is manufactured with a supporting bracket that requires removal to replace the filters ensures that the filters cannot be drawn through the unit.

Bag filters

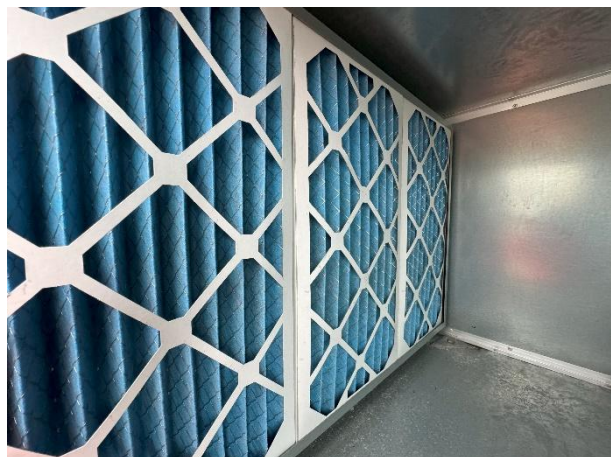
The first component on the return air inlet side of the AHU is a set of ISO Coarse 80% panel filters. Whilst it is possible to retrofit a front withdrawal filter frame for this set of filters, the width of the unit and access limitations will inhibit replacing the filters effectively as there will be a requirement for P clips to secure the filters into position on the far non access side of the AHU. It would not be possible for a maintenance engineer to replace the filters and ensure the P clip securely holds the filters in place preventing air bypass. The way the existing filter frame is manufactured with a supporting bracket that requires removal to replace the filters ensures that the filters cannot be drawn through the unit.

Return air panel filters

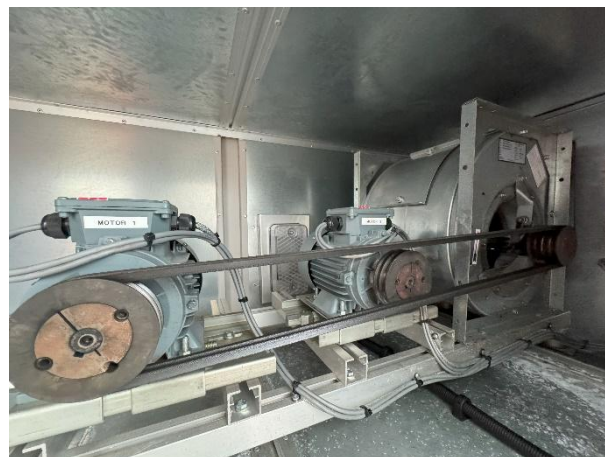
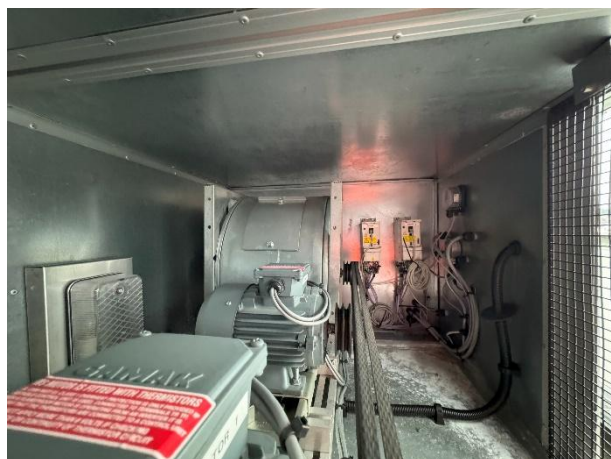
The belt driven extract fan is a DIDW type fan with run and standby motors in the air stream. The standby motor was not belted up to the fan pulley, therefore, if the existing motor was to fail there would be no extract airflow. During our survey, the inverter keypad stated Fault 9 which indicates motor overtemperature. We recommend the DIDW belt driven fan and motors are upgraded to run and standby energy efficient direct drive EC plug fans. A critical spare EC plug fan should be supplied in the unlikely event of failure.

Belt driven extract fan with run and standby motors

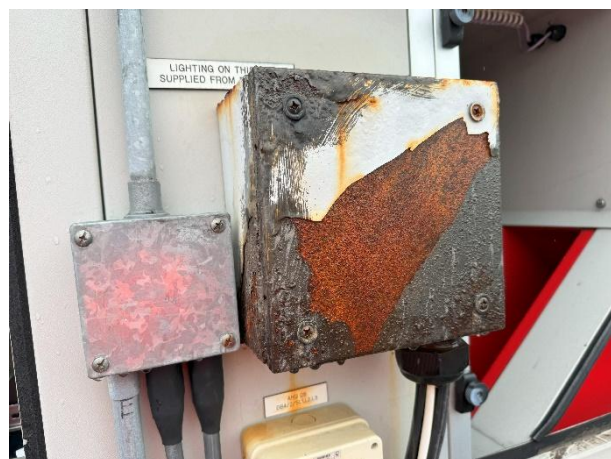
It was noted during our survey that the bulkhead lights were not operational throughout the AHU. The port holes on the AHU have blown and no longer fit for purpose. A total of four hinged access doors on the AHU contained no port holes to view the internal components. The clamped access doors on the AHU also contain no port holes. The terminal box on the external AHU casework that houses the cable entry for controls cabling is completely corroded and requires replacement. The isolators for the motors show signs of degradation.

Terminal box

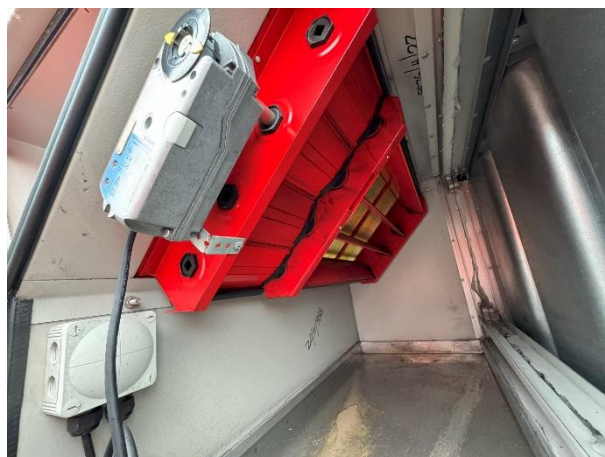
Air off side of plate heat exchanger in extract air stream face and bypass damper

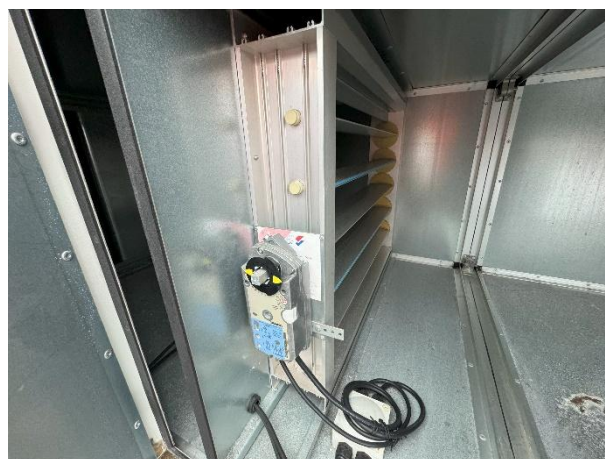
An exhaust damper is installed after the attenuator. The damper utilises plastic cogs and has the damper actuator within the airstream. There is some corrosion within the exhaust section between the exhaust damper and exhaust cowl.

Exhaust damper

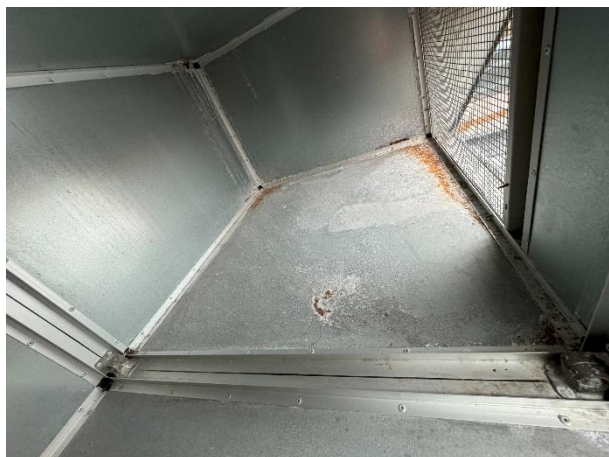
Exhaust section with signs of corrosion

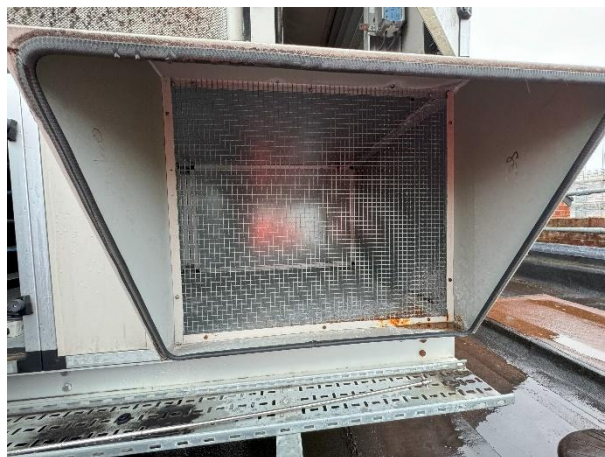
The distance between the exhaust cowl and the fresh air intake is minimal and could cause recirculation should prevailing winds direct exhaust air back into the fresh air intake, potentially compromising air quality and system efficiency.

Exhaust cowl

The exhaust cowl is within 1m of the fresh air inlet louvre therefore should be removed. A new 90-degree section of ductwork should be installed facing away from the fresh air inlet louvre connected to a new exhaust cowl to mitigate the risk of cross contamination of airflows.

- Replace the main heating coil to suit the new air volume.
- Remove exhaust cowl and install 90-degree duct and new exhaust cowl to reduce risk of air recirculation.

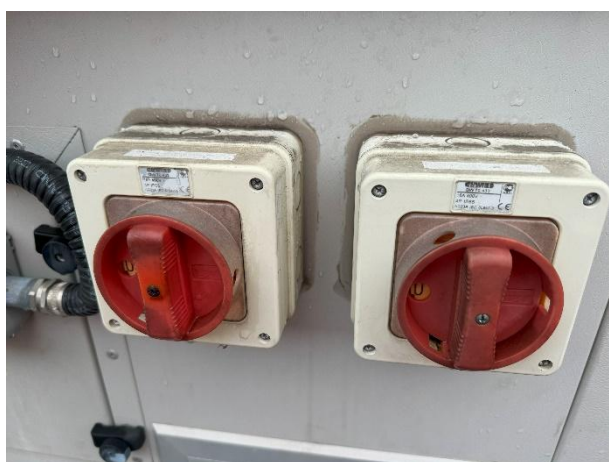
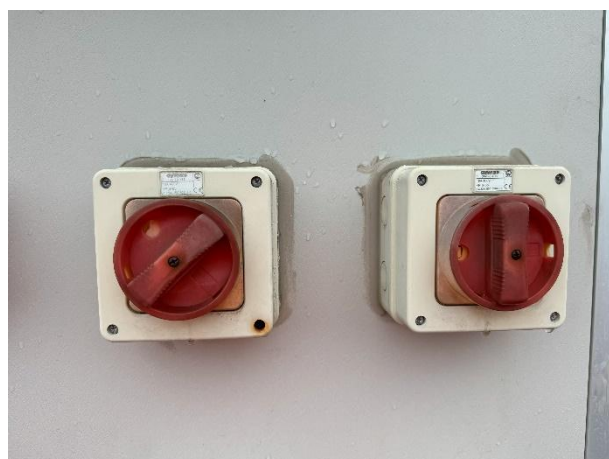
Isolators

- Replace the isolators.
- Supply and install four new hinged access doors c/w portholes to replace the existing access doors without.
- Replace the hinged access doors that currently have portholes with new access doors c/w portholes.

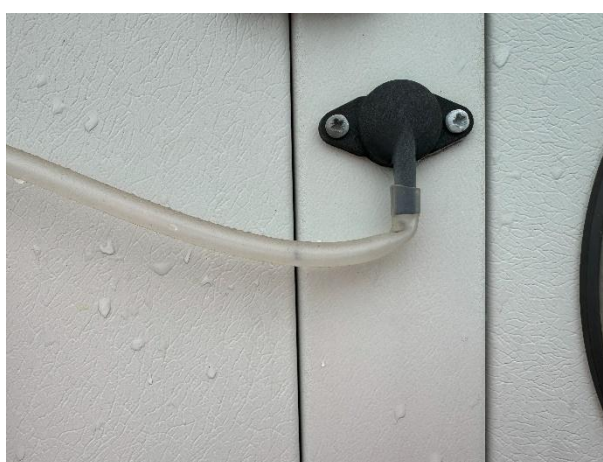
Kinked tubing for manometer

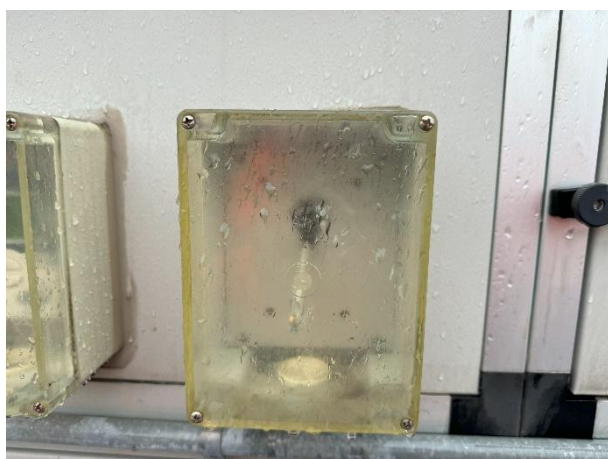
Missing inverter keypad
