AHU Condition Report

EastWest, Nottingham

Reference: Q1647/24.07.2024

Air Handling Unit - Condition Report

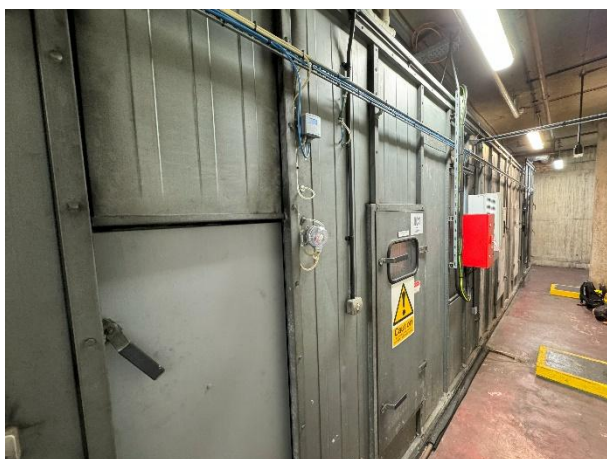
Overview of AC1

To facilitate safe access for our engineers, the Air Handling Unit (AHU) was temporarily deactivated using the local inverter installed on its casework. This allowed for a comprehensive assessment of its components. Unfortunately, the original design data for the AHU is unavailable; however, some Operation and Maintenance (O&M) records may be available on-site. During our survey, we observed the inverter operating at 23.5 Hz, suggesting that the AHU is controlled via a pressure set point from the Building Management System (BMS).

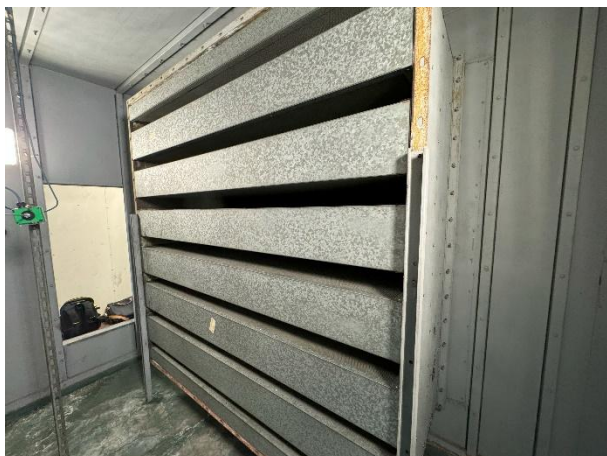
The frost coil is the next component within the AHU and is in poor condition with the fins deteriorating. The panel and bag filters seem to be in reasonable condition and should continue to be monitored and replaced regularly in line with ongoing maintenance requirements. An attenuator is installed after the bag filters which seems to have been installed in September 2008 and is in reasonable condition with some minor signs of corrosion.

Attenuator

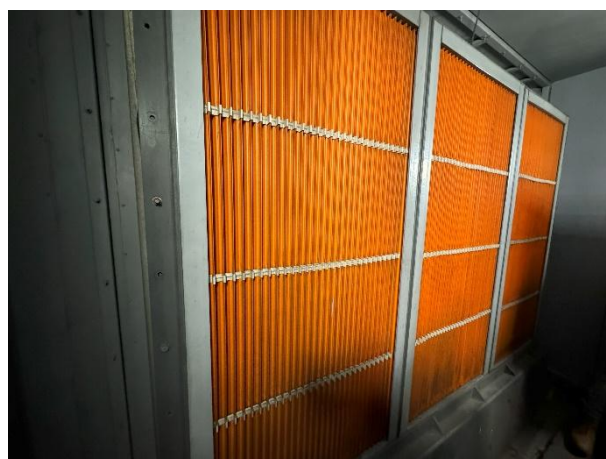
The main heating coil, like the attenuator, seems to be a replacement. Although the installation date is unclear, the coil is in reasonable condition with minor fin damage and some corrosion on the frame. The CHW cooling coil also appears to be in reasonable condition at first glance; however, thorough inspection revealed excessive corrosion around the coil headers. The associated moisture eliminators are in reasonable condition. A condensate pump is installed within the floor of the fan section, connected to the cooling coil's drain tray.

Moisture eliminators

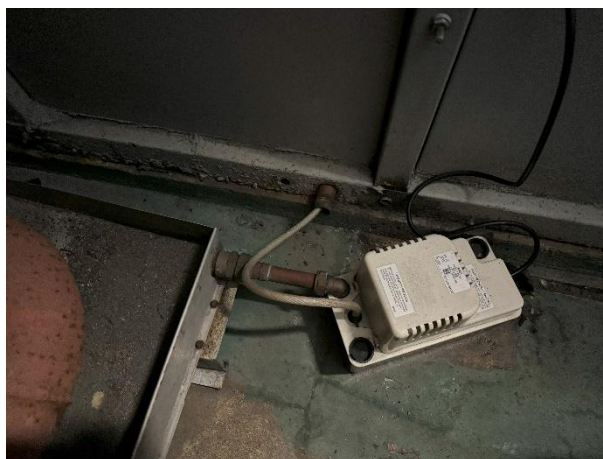
Condensate pump

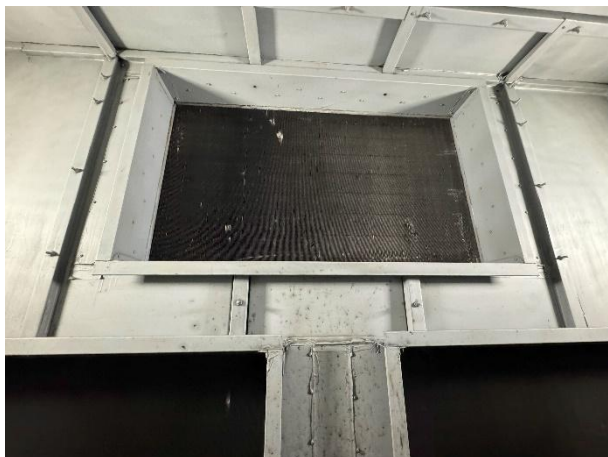
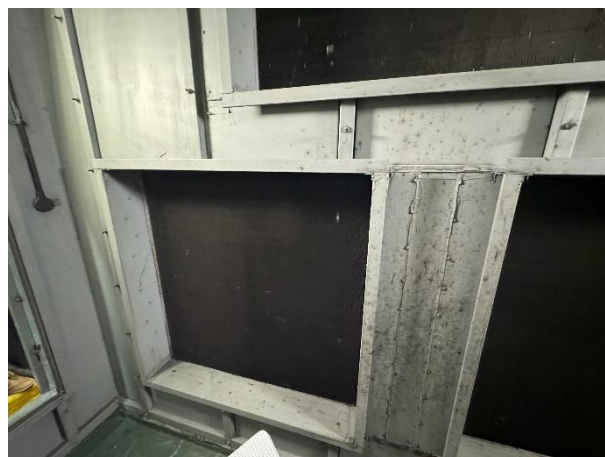
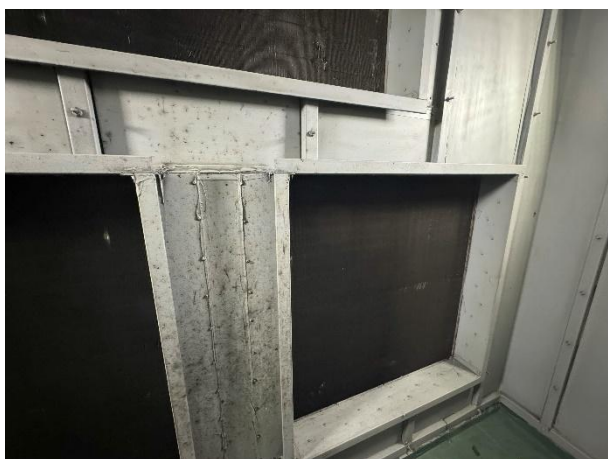
The AHU branches into 3 main ducts each with their own duct mounted heating coils to provide zonal temperature control to the areas served. Immediately after the coils is a manual Volume Control Damper (VCD) to balance airflow. The coils were in poor condition and have exceeded their recommended life expectancy according to CIBSE guide M. There are small access hatches installed after the VCDs in the ductwork to facilitate cleaning the dampers and air off side of the coils. There is cabling obstructing the removal of one of the coils.

Duct mounted coil

- Clean and lubricate the manual VCDs.
- Clean and treat the internal corrosion throughout the AHU.

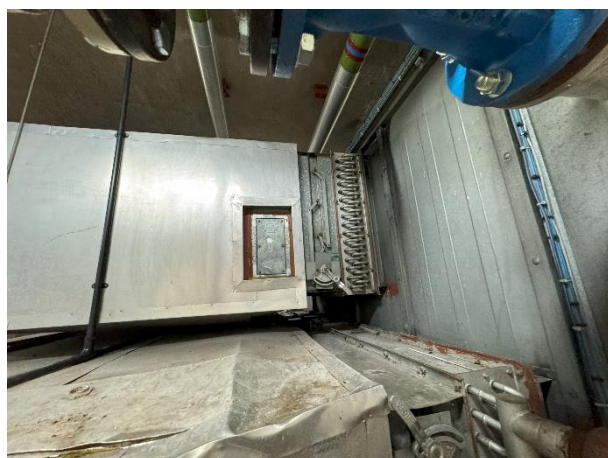
Duct mounted coil and VCD

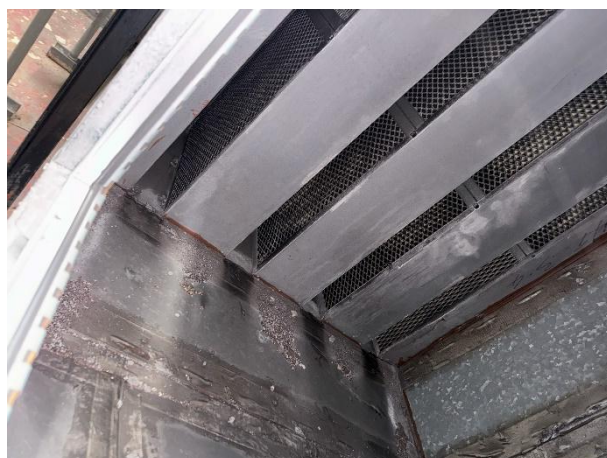
During our survey, we attempted to take pitot traverse readings in each branch of ductwork from the existing test holes. Whilst taking the readings, we encountered some anomalies and when investigating found there are duct mounted attenuators installed within each branch of duct immediately after the coils and VCDs. As a result, the readings that were taken were not suitable to establish an air volume from the AHU as ideally, we require a straight section of empty ductwork to take accurate readings.

Duct mounted attenuator

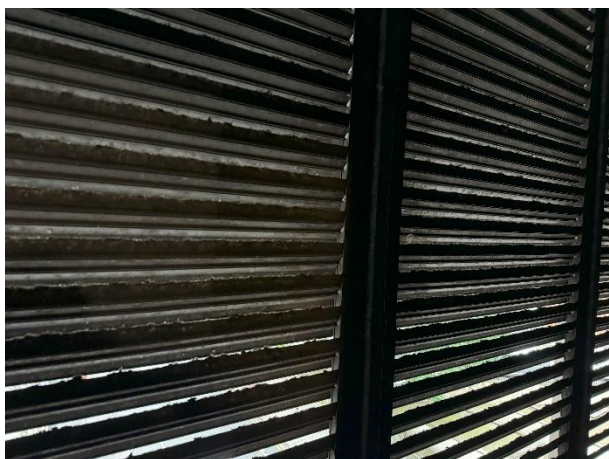
Inlet louvre

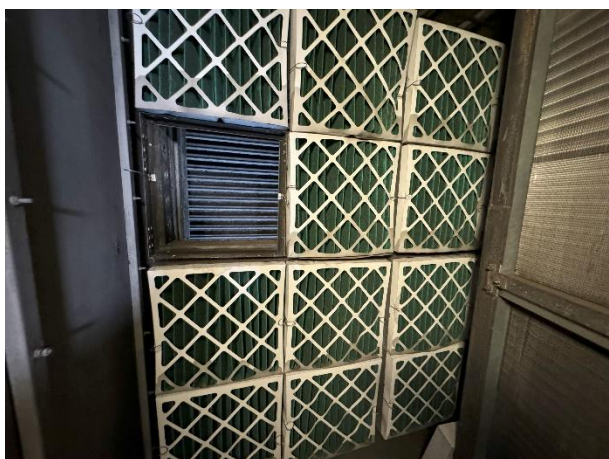
New panel filter frame and filters

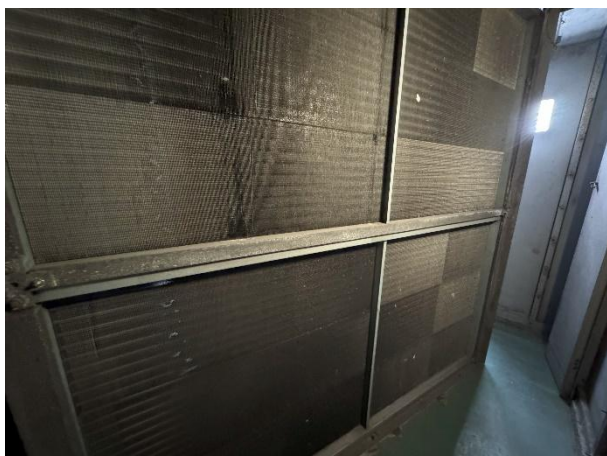
Frost coil

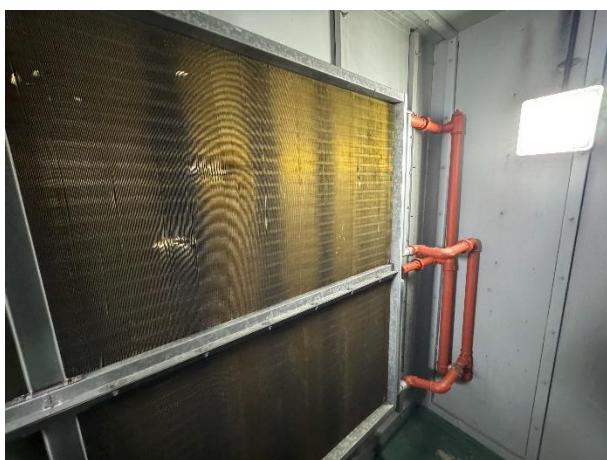
Main heating coil

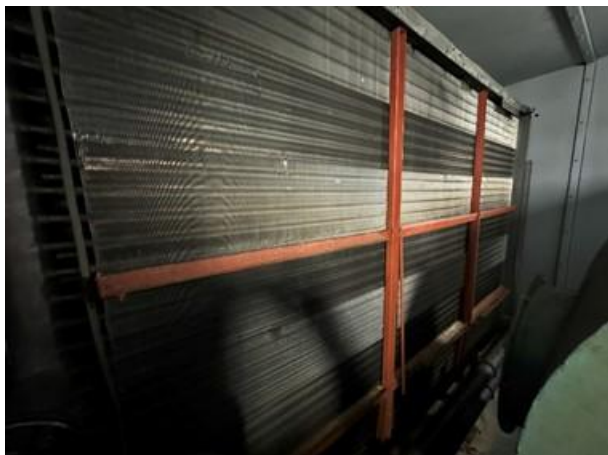
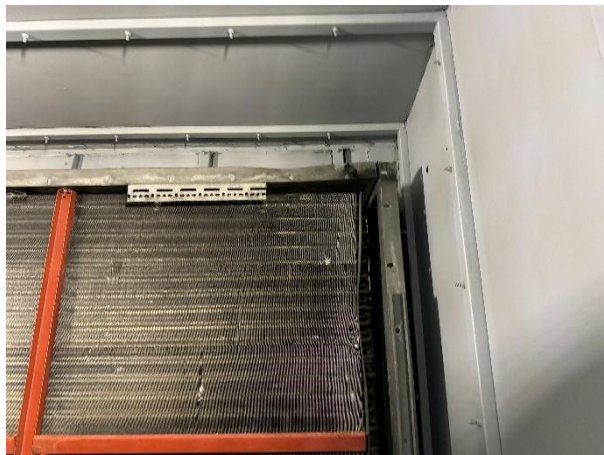
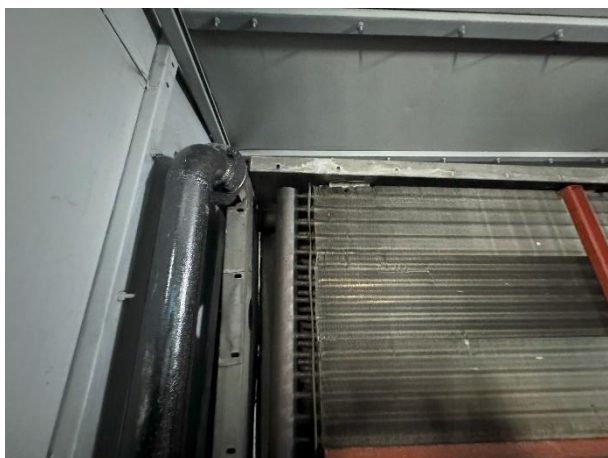
CHW cooling coil

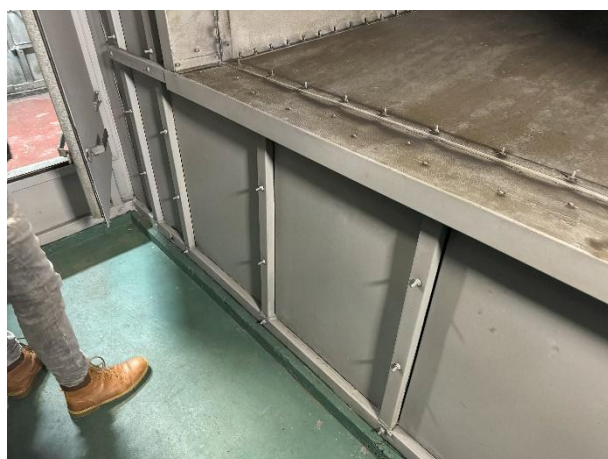
Fan outlet

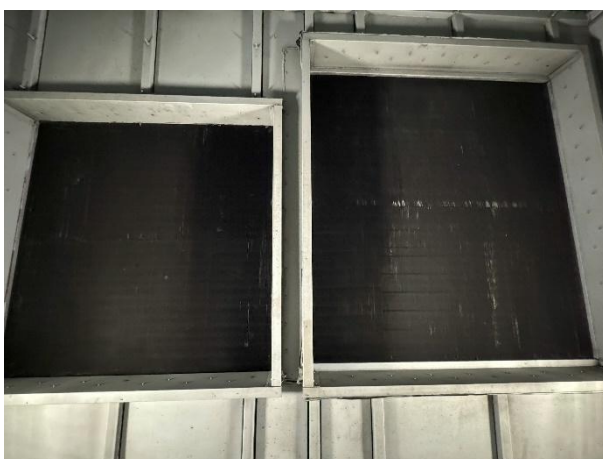
The AHU branches into 2 main ducts each with their own duct mounted heating coils to provide zonal temperature control to the areas served. Immediately after the coils is a manual Volume Control Damper (VCD) to balance airflow. The coils were in poor condition and have exceeded their recommended life expectancy according to CIBSE guide M.

Duct mounted coils

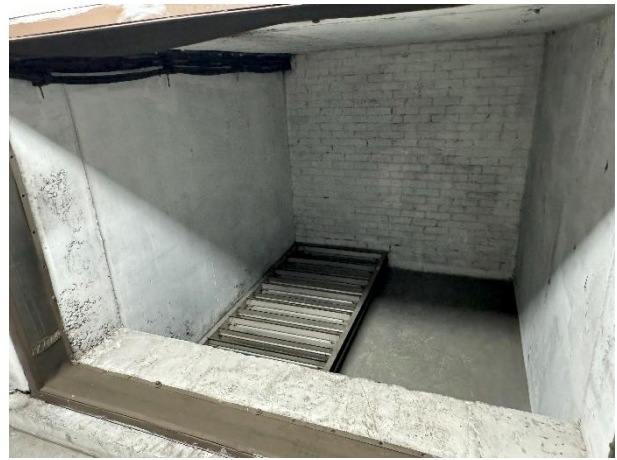
Damper

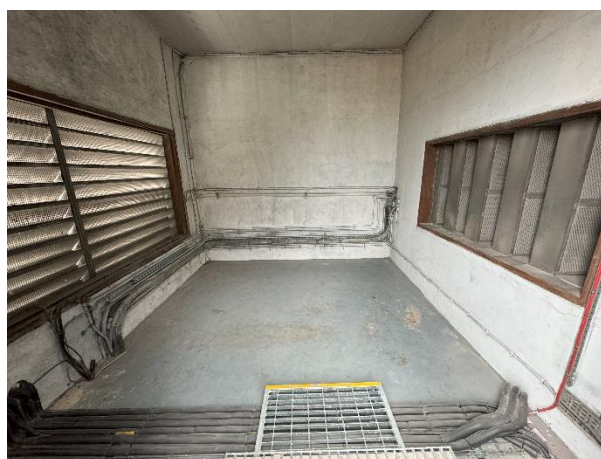
Attenuator and exhaust louvre

- Upgrade the existing belt driven fan and motor to new energy efficient direct drive IE6 EC plug fans to improve system reliability and energy efficiency.
- Due to the construction of the room that houses the fan, we recommend the new EC plug fans are installed in their own dedicated casework as the change from negative to positive pressure within the fan chamber could cause damage to the building fabric.

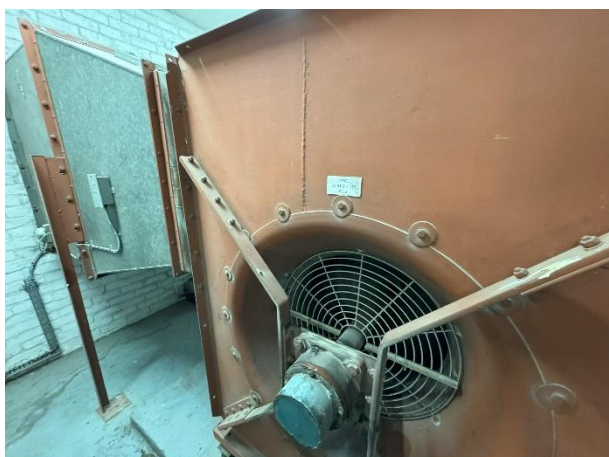
ME3

We also surveyed various other office extract fans whilst on site (ME3, and ME5) and found the units to be similar in terms of design, component layout, and condition. We would suggest they were all designed to achieve identical or similar duties.

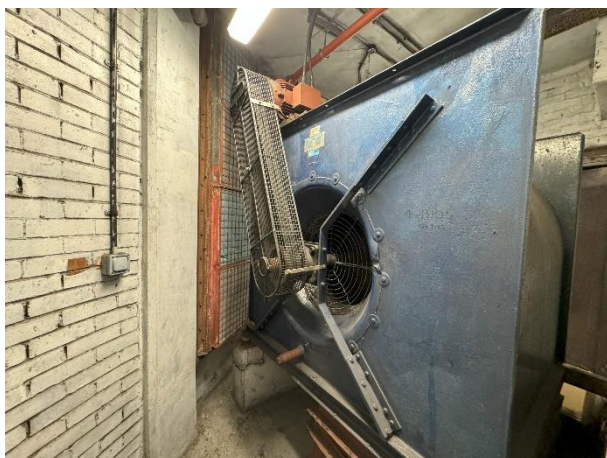
MV2

We also surveyed various other car park supply fans whilst on site (MV2, MV3, and MV4) and found the units to be similar in terms of design, component layout, and condition. We would suggest they were all designed to achieve identical or similar duties.

- Upgrade the existing belt driven fan and motor to new energy efficient direct drive IE6 EC plug fans to improve system reliability and energy efficiency.
- Due to the construction of the room that houses the fan, we recommend the new EC plug fans are installed in their own dedicated casework as the change from negative to positive pressure within the fan chamber could cause damage to the building fabric.
