AHU Condition Report

The National Maritime College of Ireland (NMCI)

Reference: Q1715/NMCI/04.05.2025

Air Handling Unit Condition Report

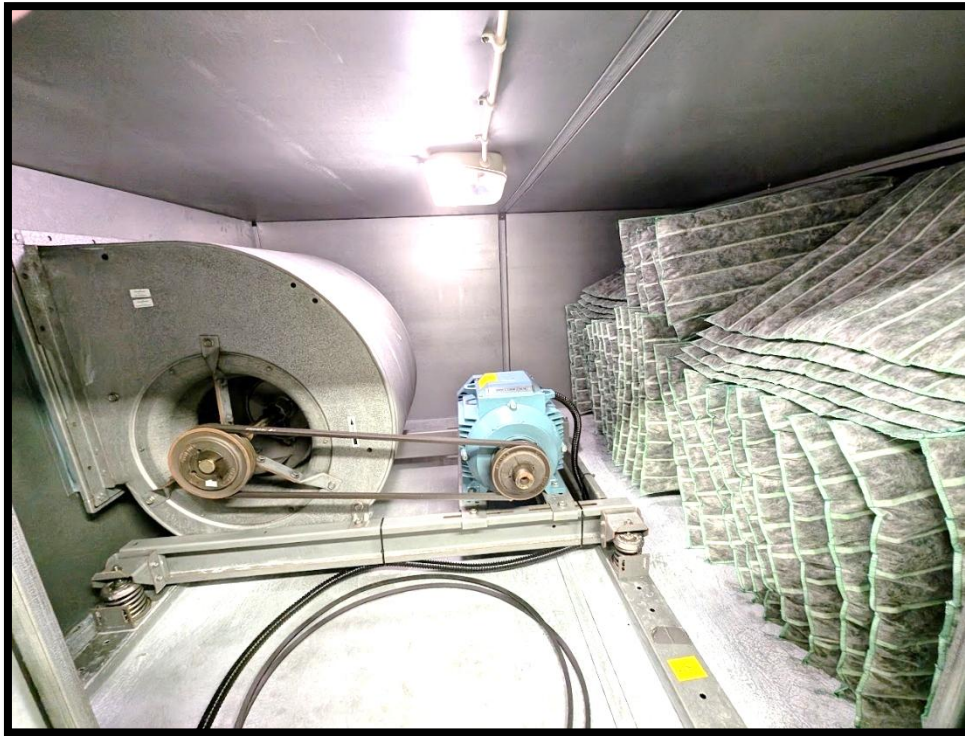
Supply Fan Section

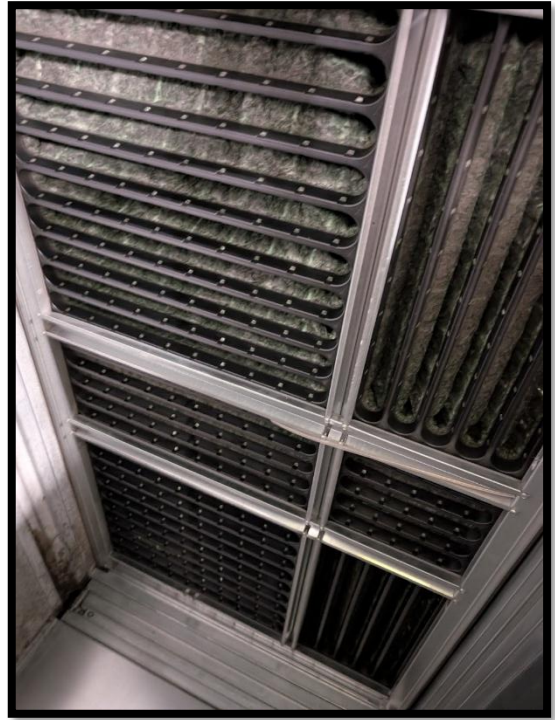
Heat Exchanger

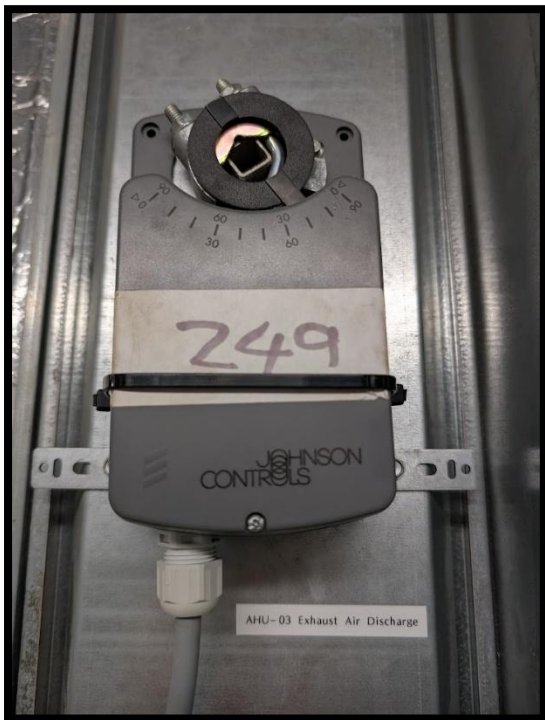
Exhaust Damper Actuator

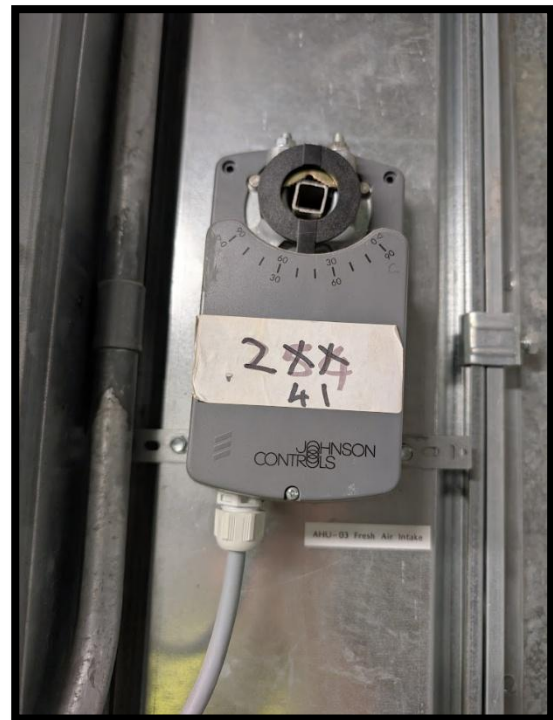
Supply Damper Actuator

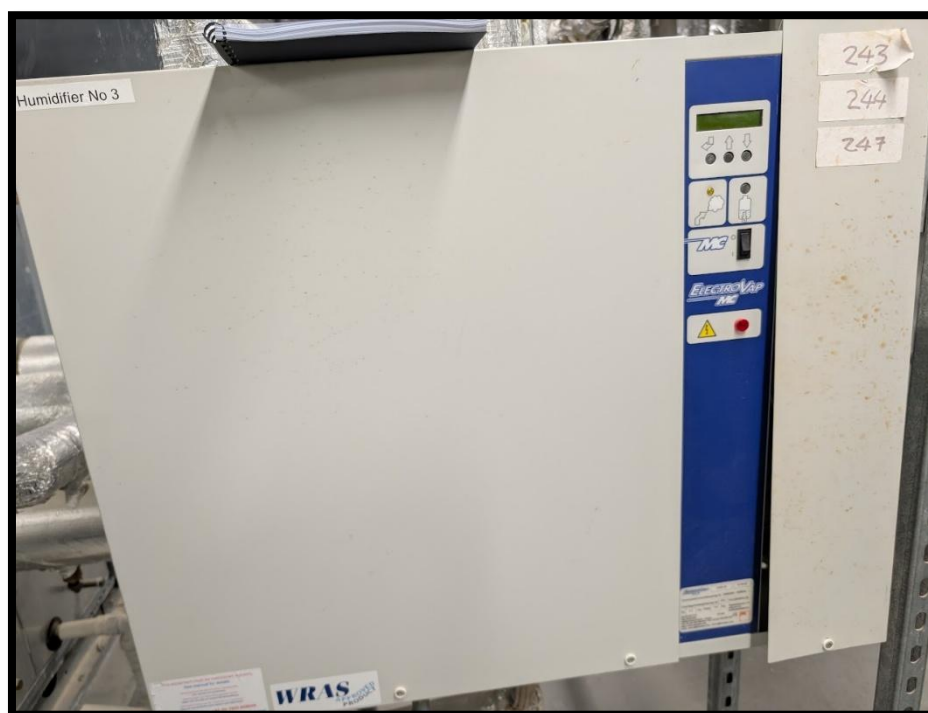
Redundant Humidifier

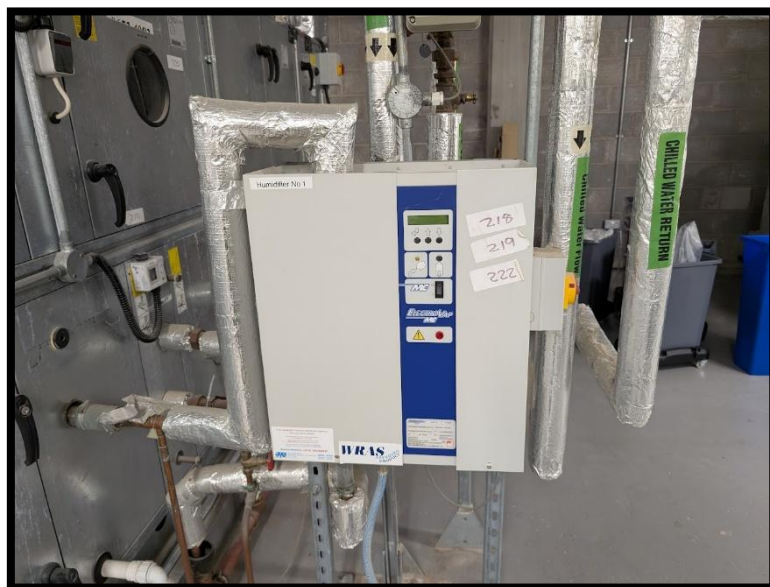
Redundant humidifier

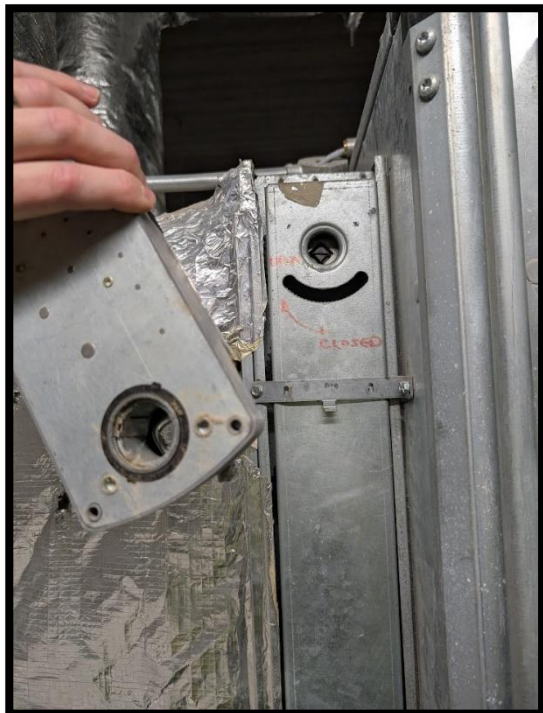
Missing Actuator on Intake Dampers

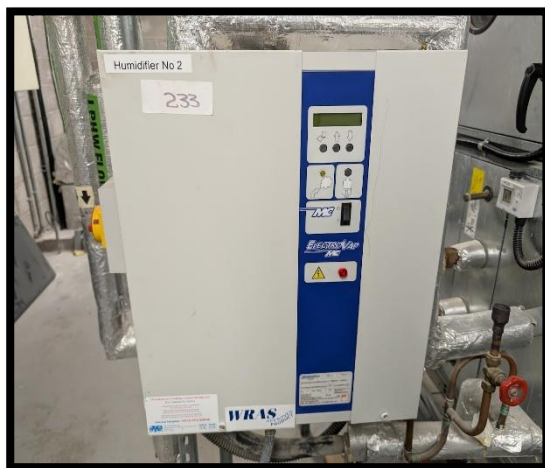
Redundant Humidifier

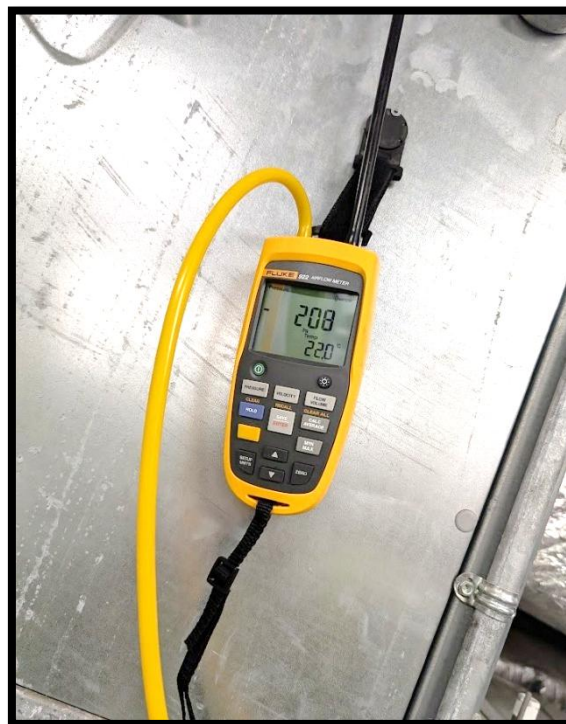
Under Duty Airflow Readings.

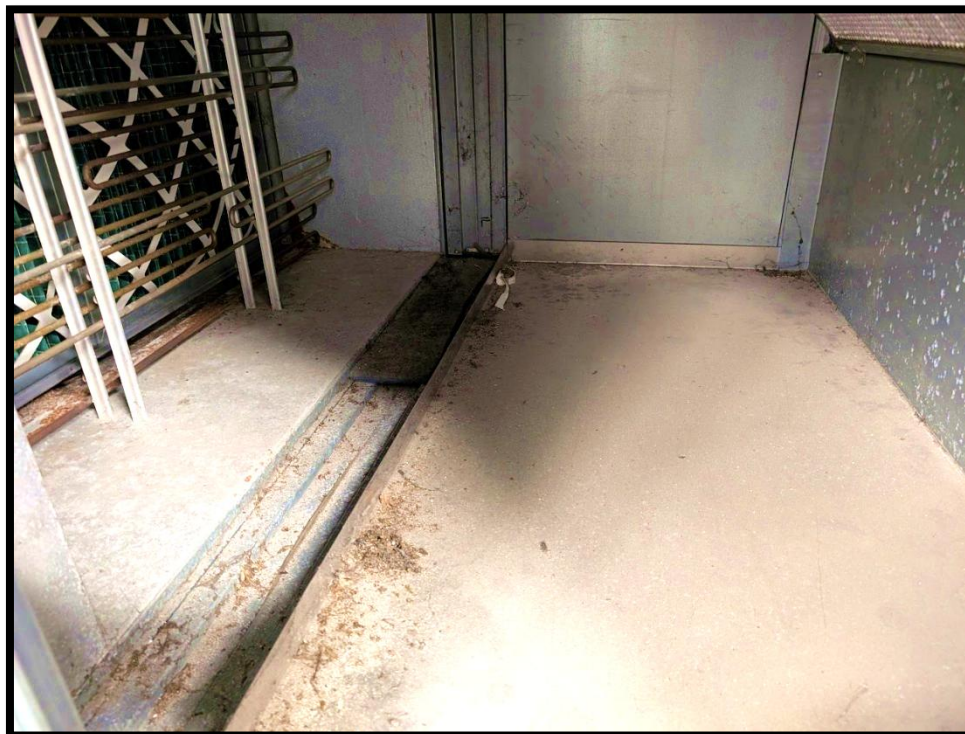
Minor Rust and Debris

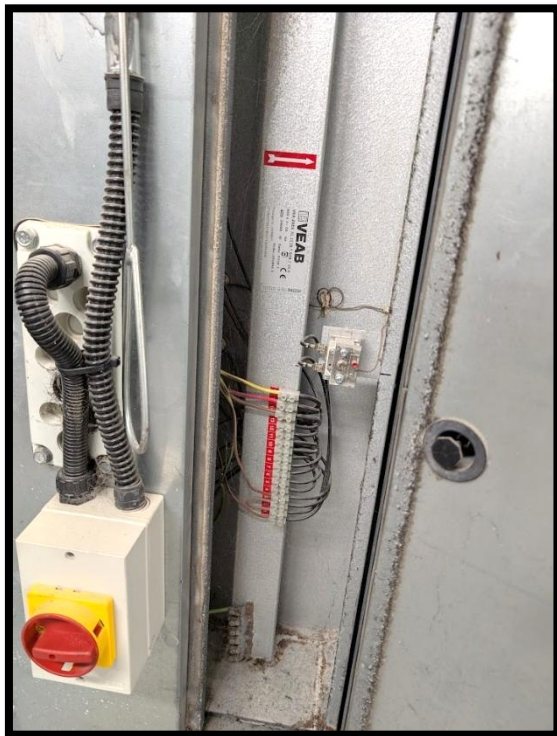
Electric Heater Battery Corroded and Located 150mm From Panel Filters.

(This applies to all AHUs)

- Replace the EHB with a modern, energy-efficient equivalent.
- Reconfigure panel layout to provide ≥ 300 mm clearance from filters, as per best practice.
- Install non-combustible filters or thermal protection if clearance cannot be achieved.

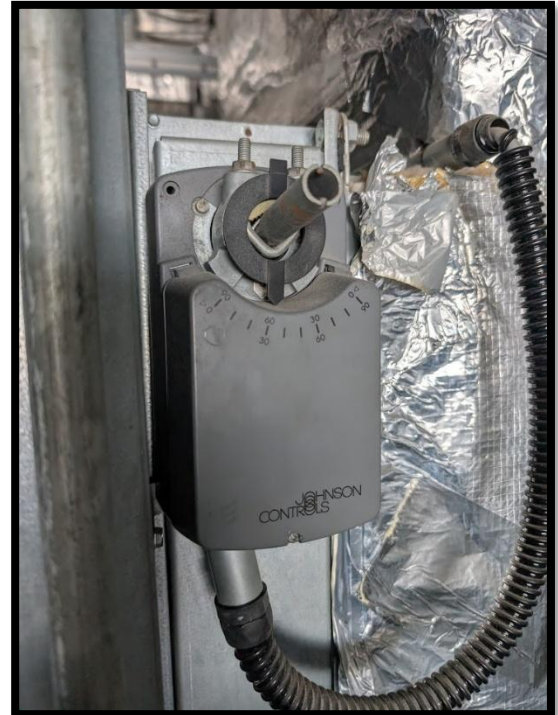
Electric Heater Battery Corroded

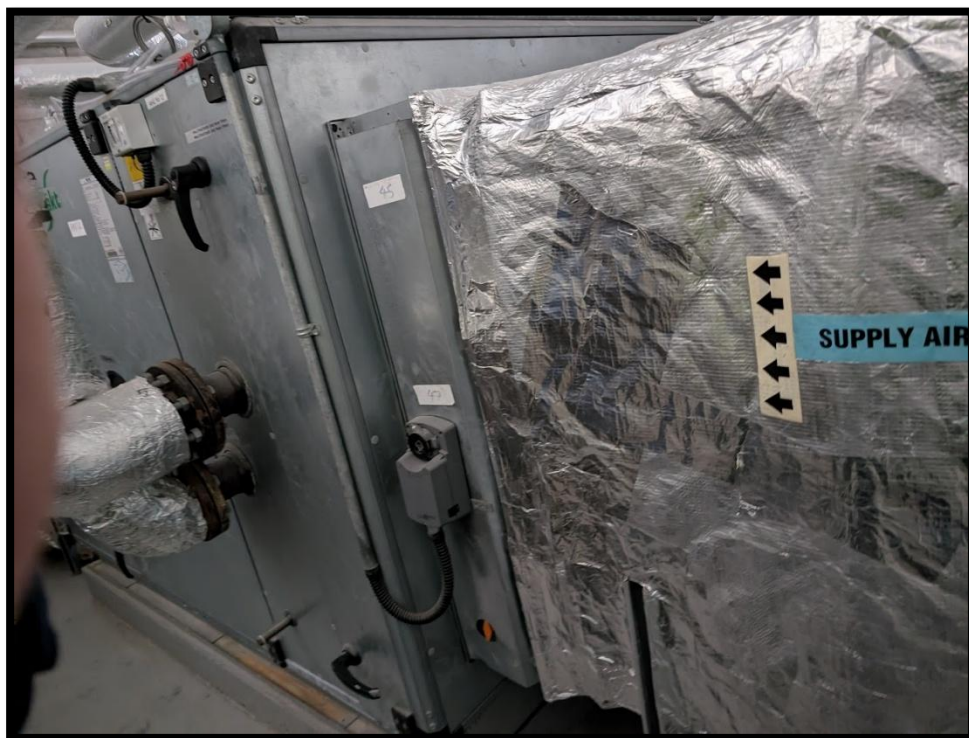
Inaccessible Damper/Intake Section

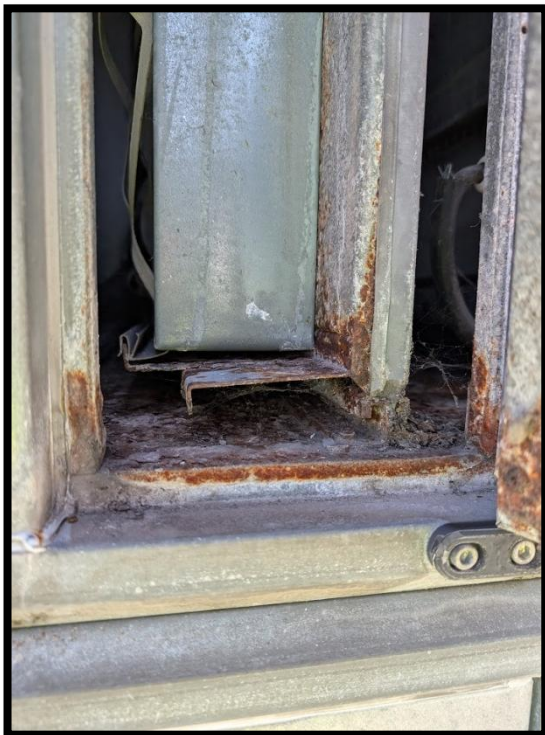
Intake Section Corrosion

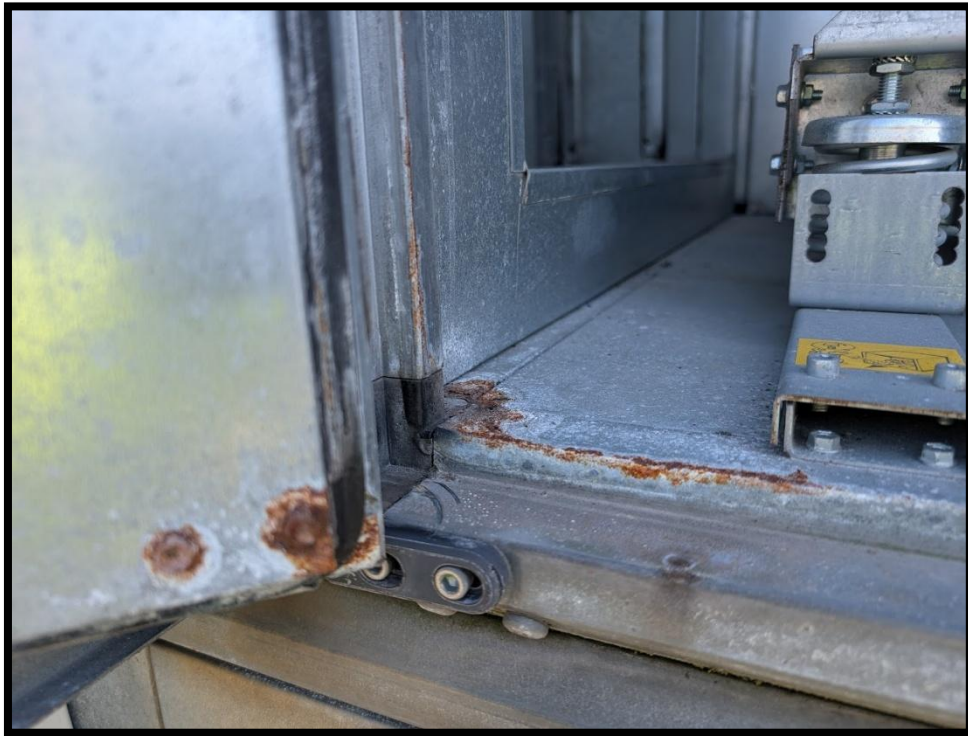
Rusting of Access Panels

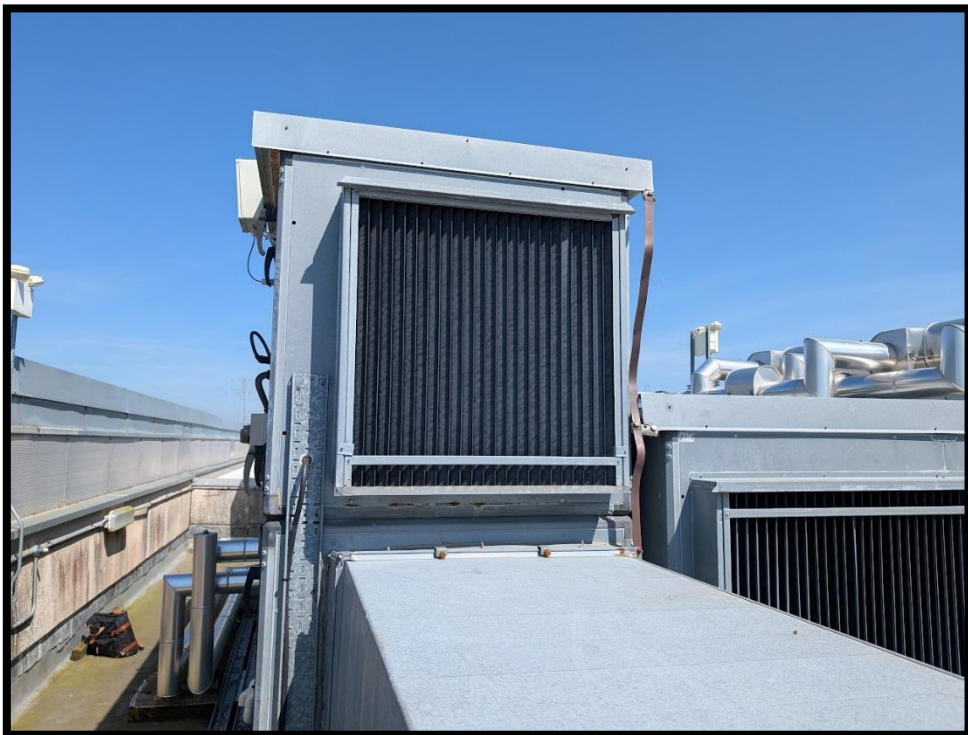
Not Fit For Purpose Intake

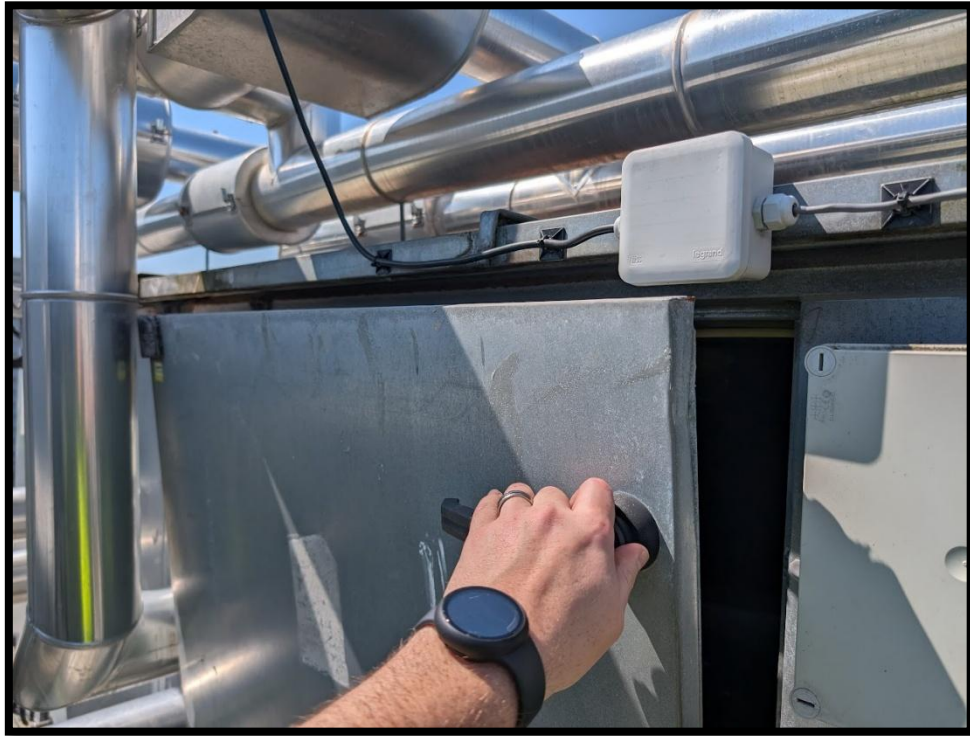
Door Unsecured

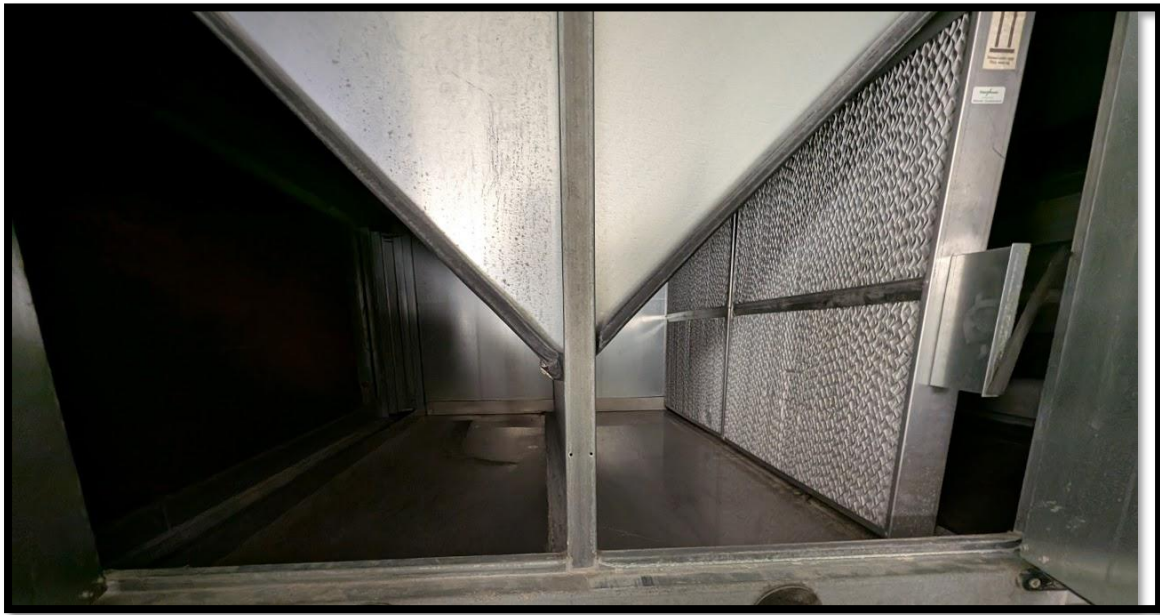
Heating & Cooling Section

For this coil, the effective cooling output may now be closer to 17.04 kW and 12.78 kW under typical conditions.

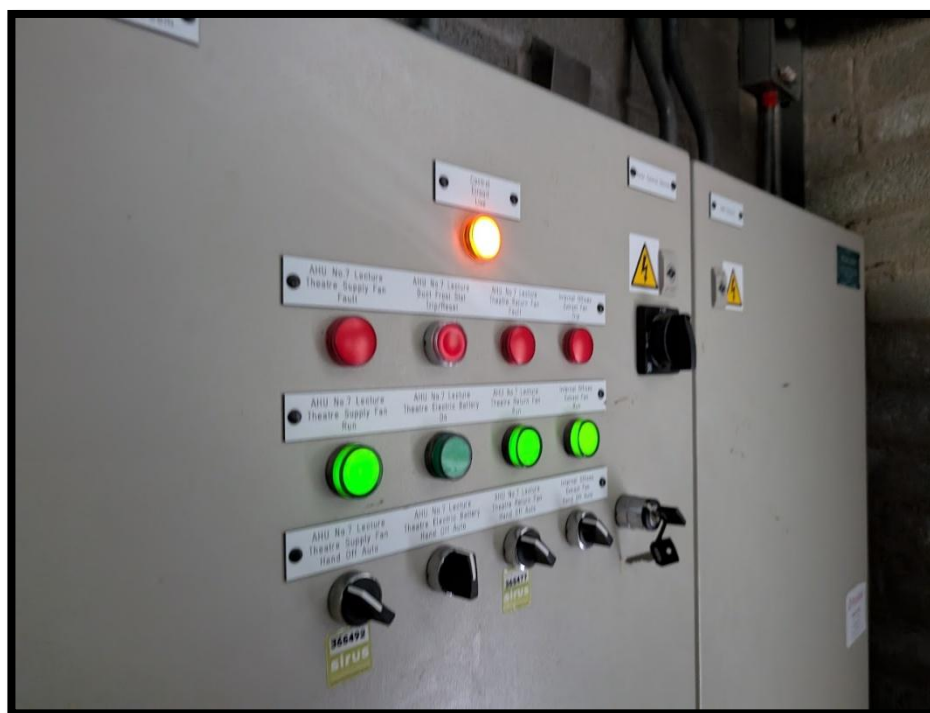
Invertors Manually Set to Reduced Duty
